Coffs Harbour Slipway – Contaminated lands rehabilitation. Soil Conservation Service NSW

2017 Awards of Environmental Excellence Coffs Harbour Slipway – Contaminated Lands Remediation K Laboyrie¹, ¹Soil Conservation Service, Sydney, NSW

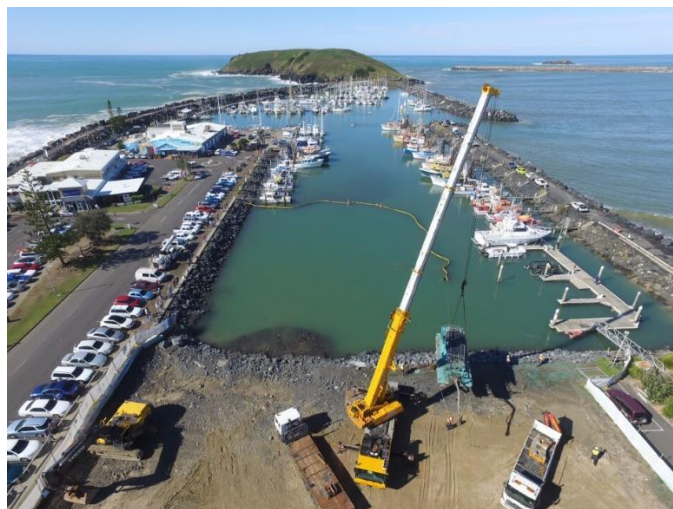
Franna Crane Lifting In Dredge AS THE East coast low subsides

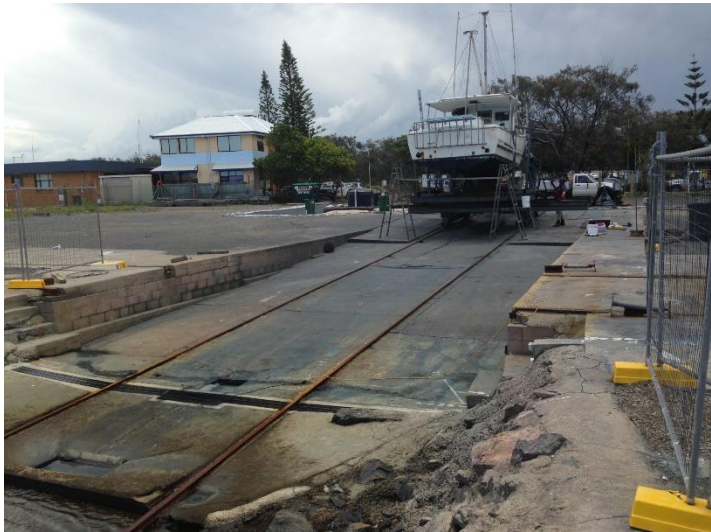
100Tn Coffs Harbour Slipway with Vessle prior to works. Note the drainage pits in the foreground that go under during high tide.

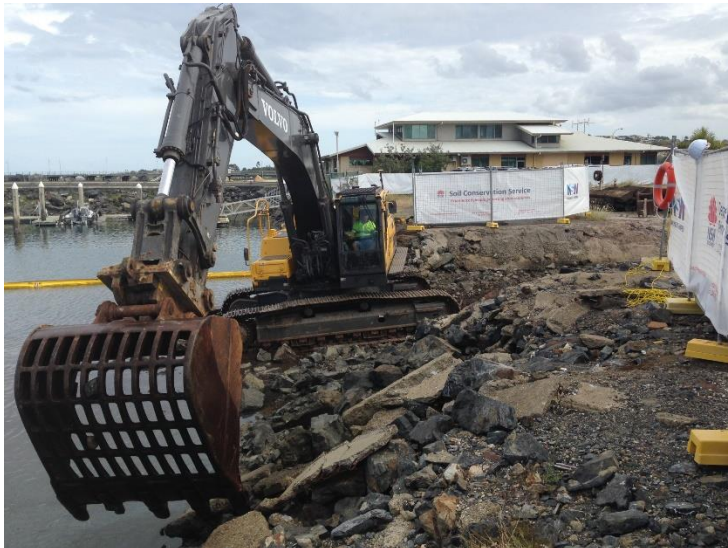
Shaker Bucket used to split various rock sizes

The ballast material was not able to be recovered by excavator as proposed in the specification. To maximise resource recovery the SCS brought in a shaker screen to split the rock/sediment matrix into different waste streams for recovery.

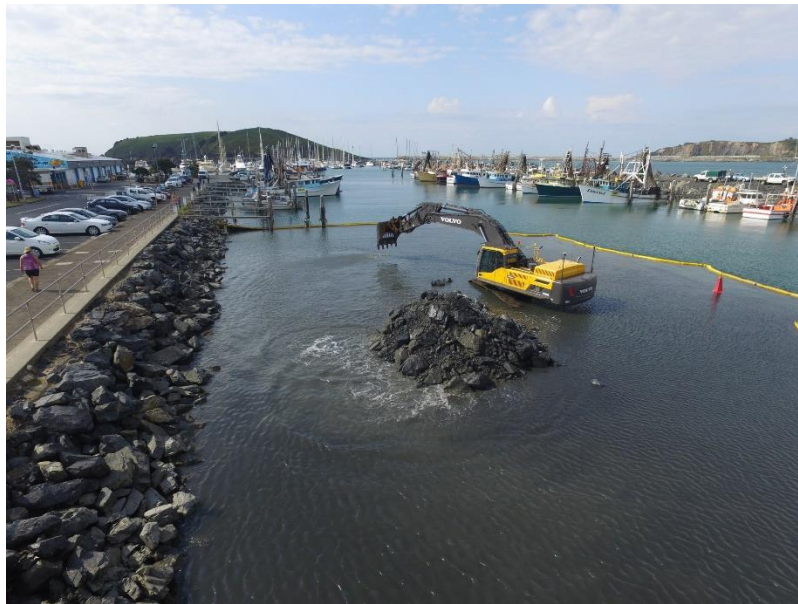
Recovery of submarine section of the slipway.

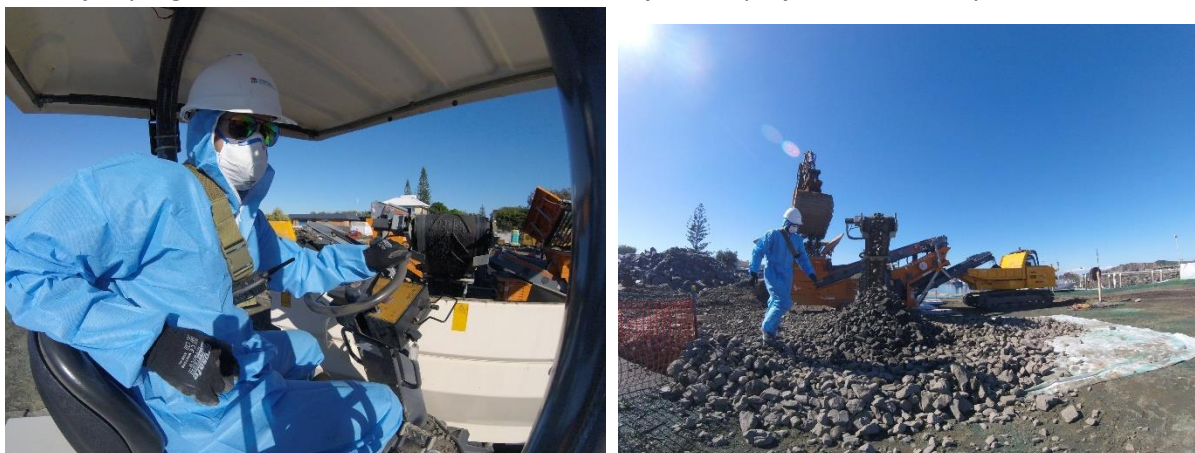
Full PPE during handling of Hazardous Materials. Uncomfortable in the heat to say the least. A challenge for workers

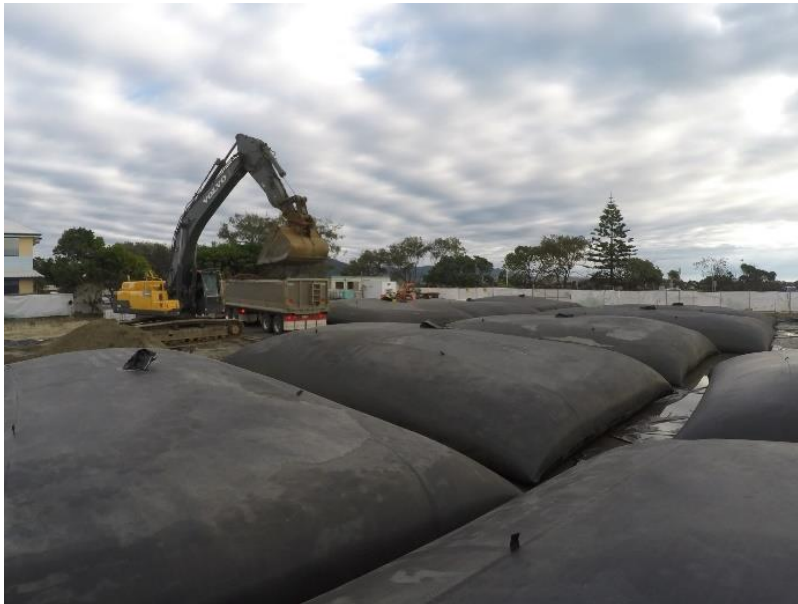
Geosynthetic Bags filled with contaminated sediment after de-watering being loaded out to waste management facility.

The SCS heavily altered the construction methodology proposed in the Specification to reduce environmental and human risk. This was done by moving from a land based approach to dredging campaign. Using an in-line flocculant and geo-synthetic de-watering system for marine sediments meant that the contaminants were isolated at all times. This resulted in a safer and cleaner job with less impact on the public. This methodology also resulted in over 4,760Tonnes of contaminated sediment being removed, far more than originally planned.

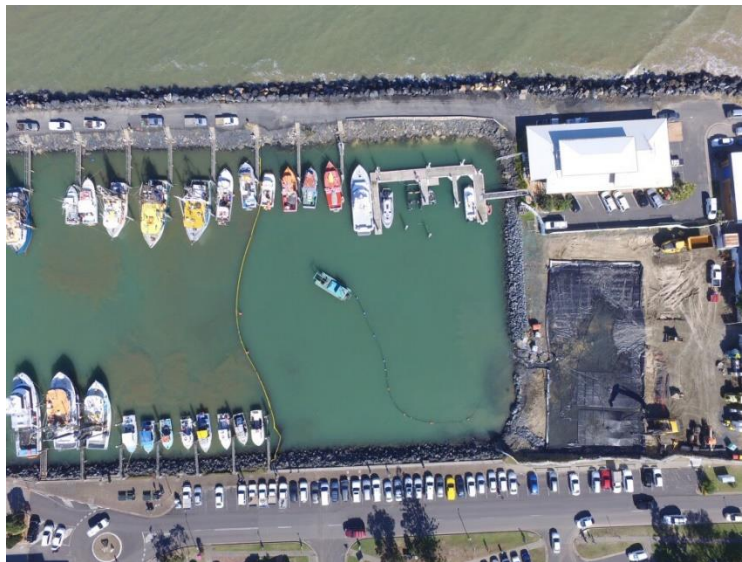
Start of Dredging Operations only days after the East Coast Low: Note Work area within Boom is cleaner than the natural harbour.

Marine- With coffer dam construction to undertake dry works unfeasible two surface to sea bed sediment booms were deployed to contain the construction waters. This was only feasible due to the relatively low energy environment within that portion of the marina and steady tidal fluctuations. These booms were a source of many issues throughout the project and their non-conformance to intended standard use created numerous problems with maintenance.

Some of these issues included placement and maintenance, pinning of the curtain and a fish kill incident (Outlined Below). This being said they performed extremely highly in their ability to create a barrier to the “natural” marina waters and our site construction waters.

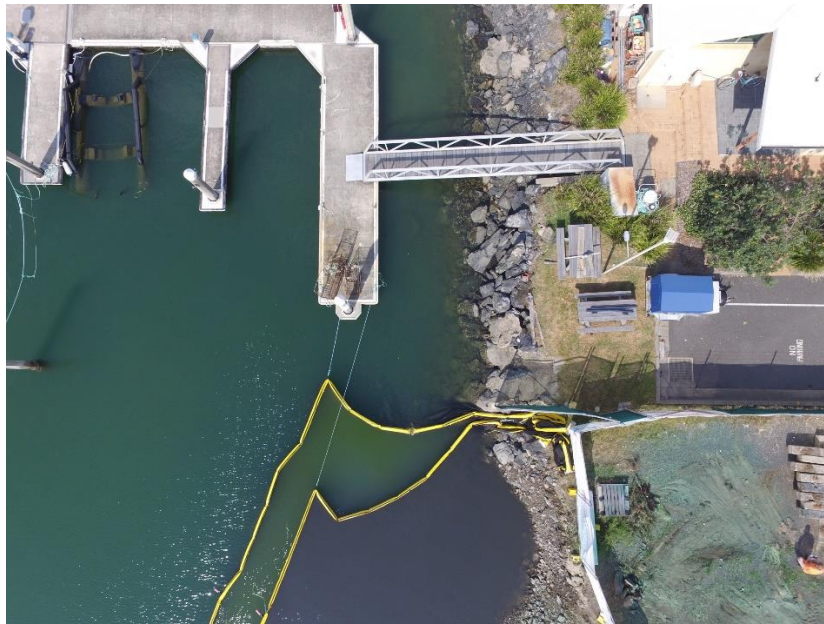
Sediment Booms working as intended.

Two separate surface to sea bed (curtain depth up to 6 Meters draft) sediment booms were imposed as a requirement by the EPA. Working outside of the design intention for sediment booms, which are not intended to extend to the sea bed had a range of expected and unexpected consequences. Placement and maintenance of the booms needed to be undertaken by commercial divers in very low visibility. As the slipway was recovered at low tides and sediment was mobilised it moved towards the inner boom and settled out on the excess curtain available at that tidal range. This resulted in the boom slowly becoming pinned and not recovering with incoming tides.

The double boom system caused a closed system with little to no water mixing. When thousands of whitebait were driven in between the booms overnight the sudden mass of biota in the limited space crashed the inter-boom Dissolved Oxygen levels rapidly resulting in severe fish kill. Water

quality monitoring and agreement with the EPA resulted in the opening of the outer boom ends to prevent further occurrence with the secondary curtain able to be closed in the case of a breach.
