# **TATHRA WILDFIRE – Erosion impact assessment & use of the Collector App to guide community response**

# Wildfire swept into Tathra on 18 March 2018

# GIS & Collector APP come into their own

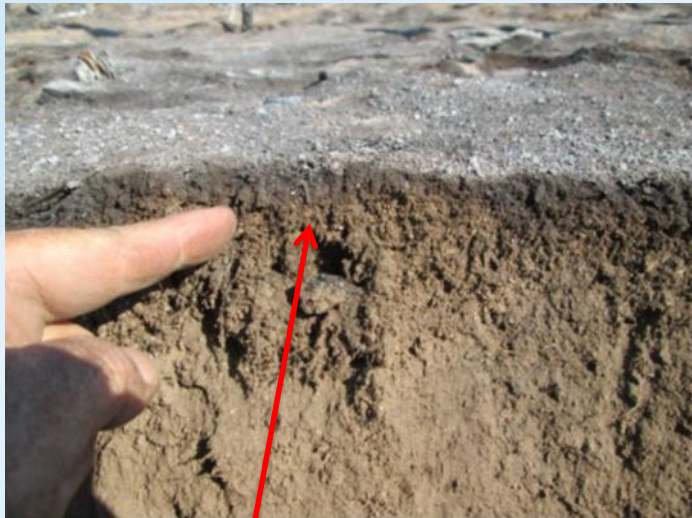
A combination of cooked soils, zero ground cover, and dead vegetation...area will take years to recover.....

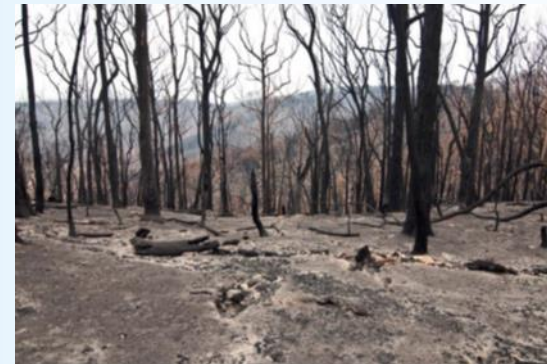
>600° C heat has cooked organic matter – soil is now hydrophobic

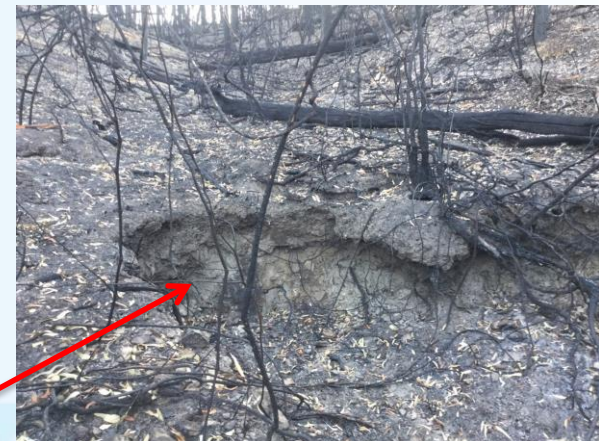
Ground cover and flow obstructions destroyed

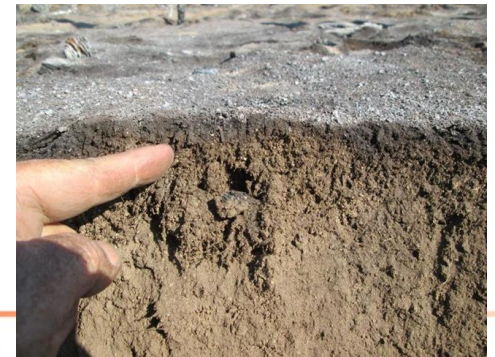
Soils either hydrophobic or deep ash beds

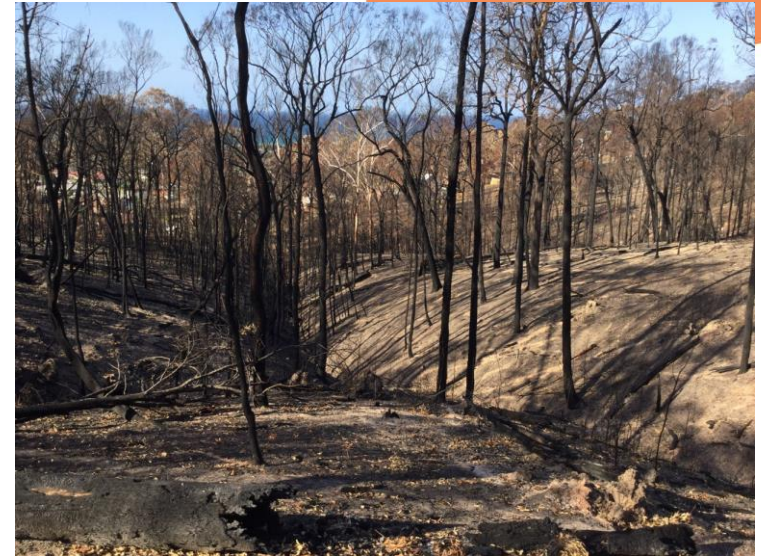
- LS & C Factor - Steep, totally denuded slopes, deep ash beds & soils that resembled fluff....

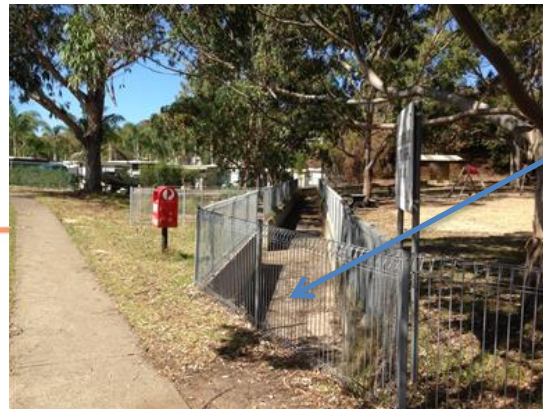
- drainage patterns that would deliver sediment and debris into storm water system

POTENTIAL FLOOD DAMAGE IN TATHRA SHOPPING CENTRE

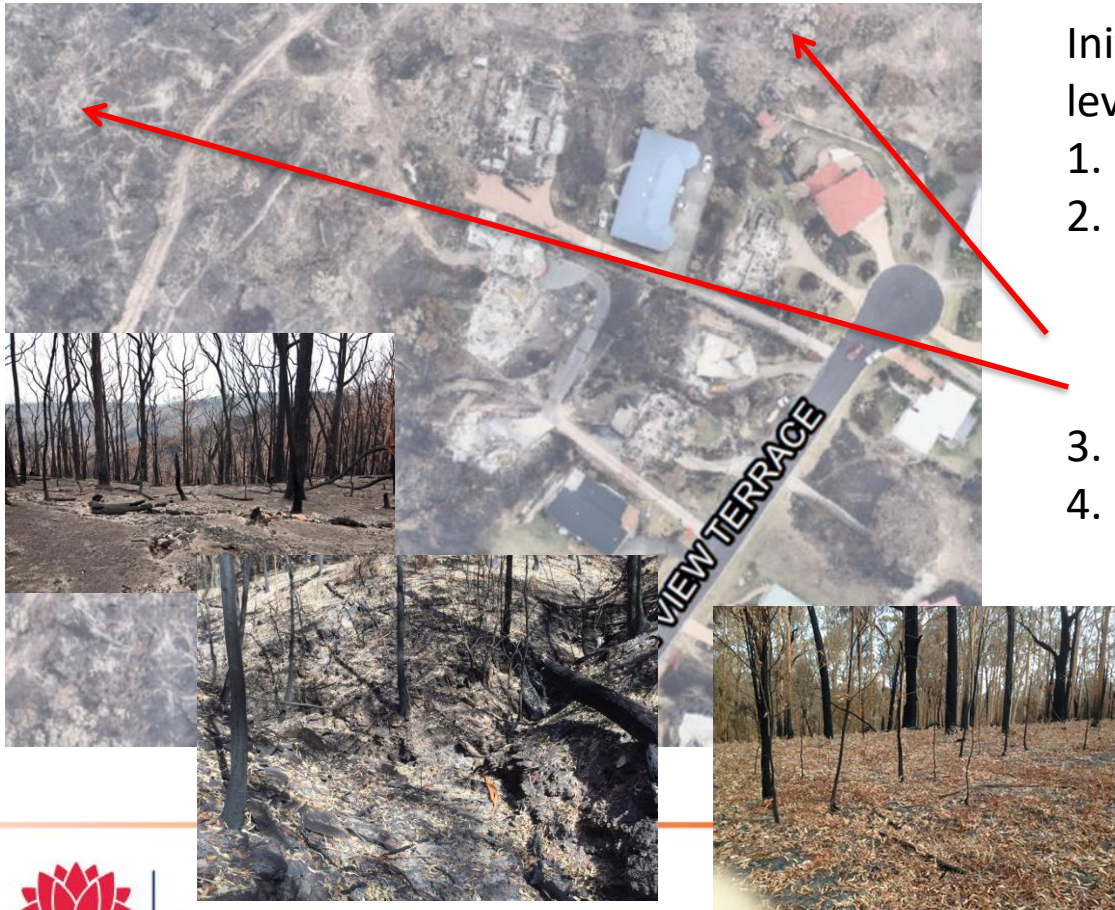
# Fire Intensity – Loss of Ground Cover

Initial inspections revealed 3 levels of fire intensity

1. Ground burn – fire creep
2. Crown Scorch – ground layers removed, trunks burnt, leaves in crowns scorched & dropped to ground
3. Total Crown Destruction
4. Fire uncovered existing erosion, and removed natural flow obstructions ie logs

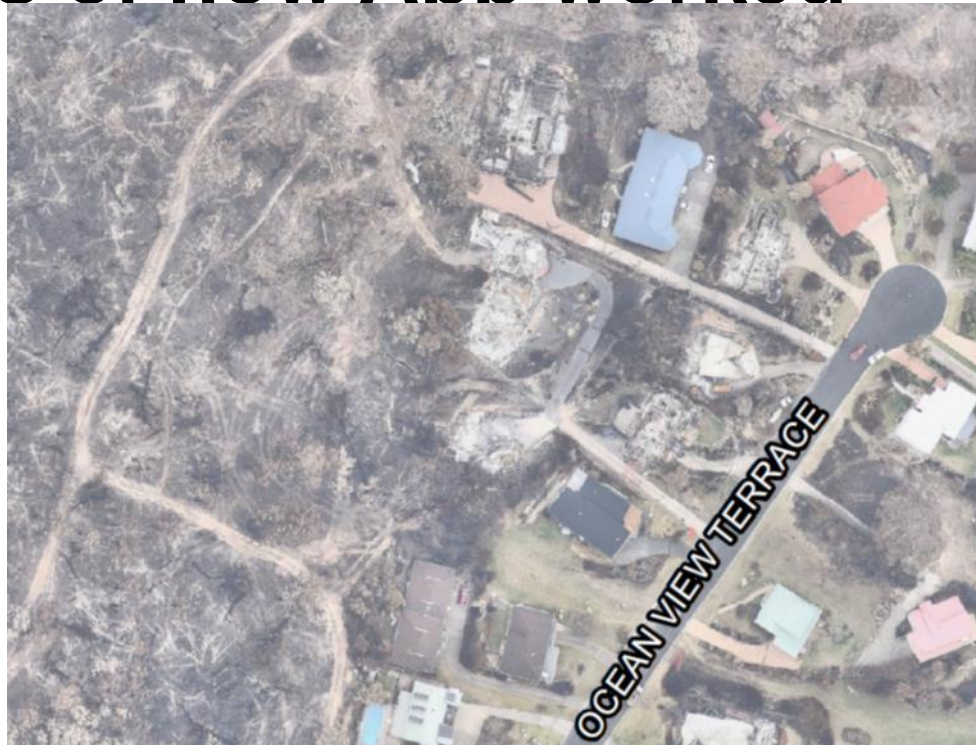
# Section of Catchment 2 loaded onto iPhone & iPad – Work Sites 95 & 98 as examples of how App worked

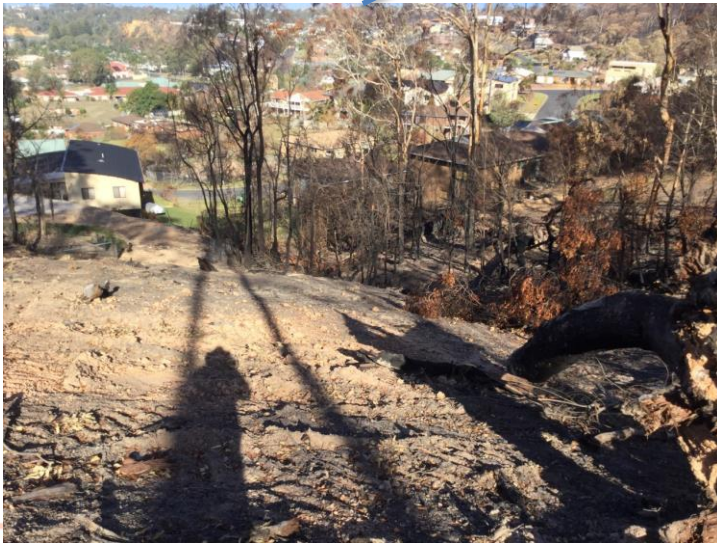
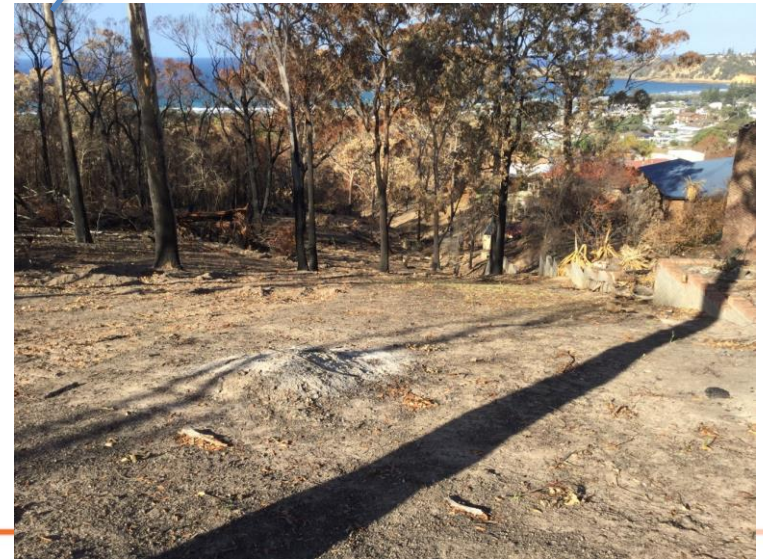
# Field Work – Site example & inputs to Works Plan

90-1.jpg	95 Other	Crown fire, no existing ground cover, steep slopes above Tathra stormwater System. Consider straw bombing/ soil binder etc	90
91-1.jpg	96 Sediment Trap	Install SED TRAP/ WWST in burnt area just above grass and fence line.	91
91-2.jpg	96 Sediment Trap	Install SED TRAP/ WWST in burnt area just above grass and fence line.	91
93-1.jpg	98 Other	Steep slopes on northern edge of Tathra . Install WWST, 4x Coir logs in flow line	93
94-1.jpg	99 Other	Increase height by covering with rock.Temp block pipe until catch ground cover returns- maintenance required to remove Sed build up. Reshape track to	94

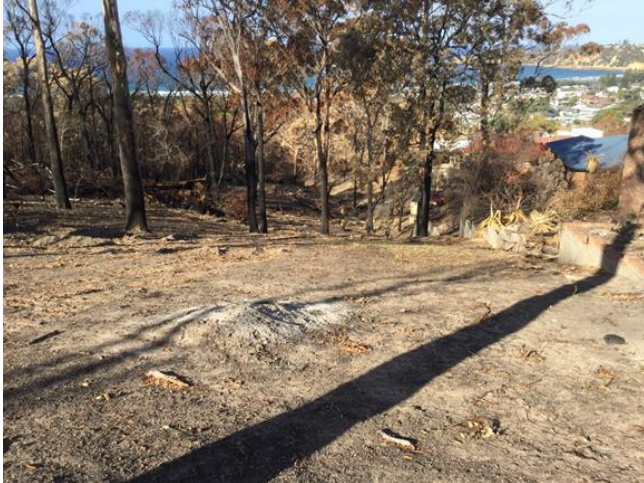
# Before & After – Site 95 Gully line control

Photo  
Apr 18

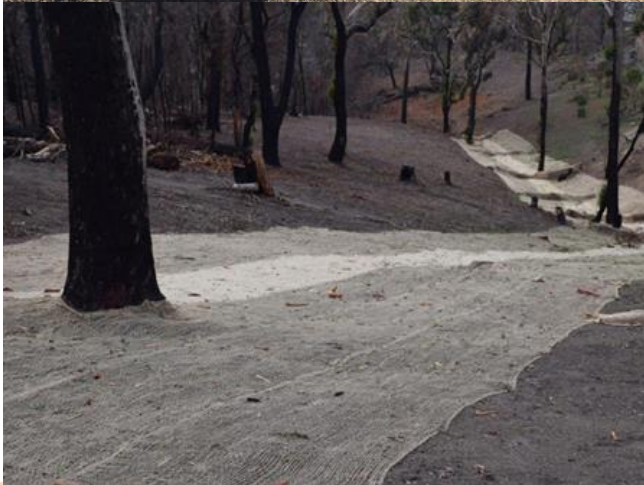
Photo Oct 18  
Sure Gro Tree  
Max

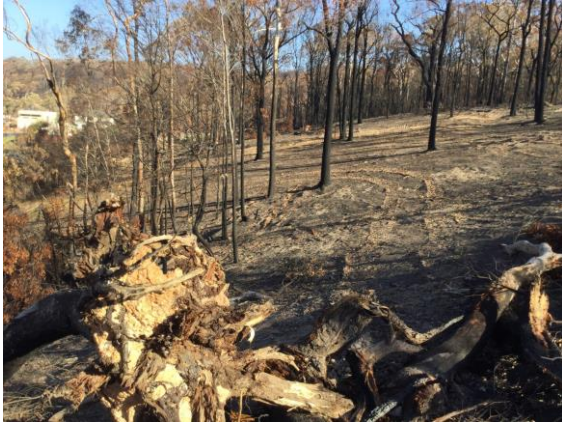
# Before & afters – Site 98 Ground Cover

Photo  
18/04/18

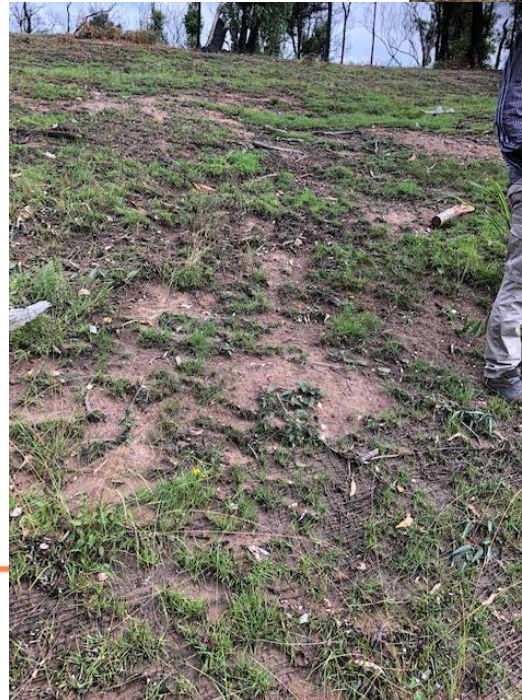
Ground cover 1  
year on – Apr 19
