NorthConnex

2018 IECA Environmental Excellence Award

The \$3 billion NorthConnex project will deliver significant benefits to road users across Sydney, with the opening of the twin nine-kilometre tunnels expected in 2020. NorthConnex is the longest road tunnel project in Australia, and will link the M1 Pacific Motorway at Wahroonga to the Hills M2 Motorway at West Pennant Hills. The tunnel will remove around 5,000 trucks daily from Pennant Hills Road, helping to improve safety, local air quality and reduce existing traffic noise. The project is being delivered by Lendlease Bouygues Joint Venture on behalf of the proponents Transurban and Roads and Maritime Services with the tunnel to be operated and maintained by NorthConnex Company Pty Ltd (consisting of Transurban and the Westlink M7 shareholders).

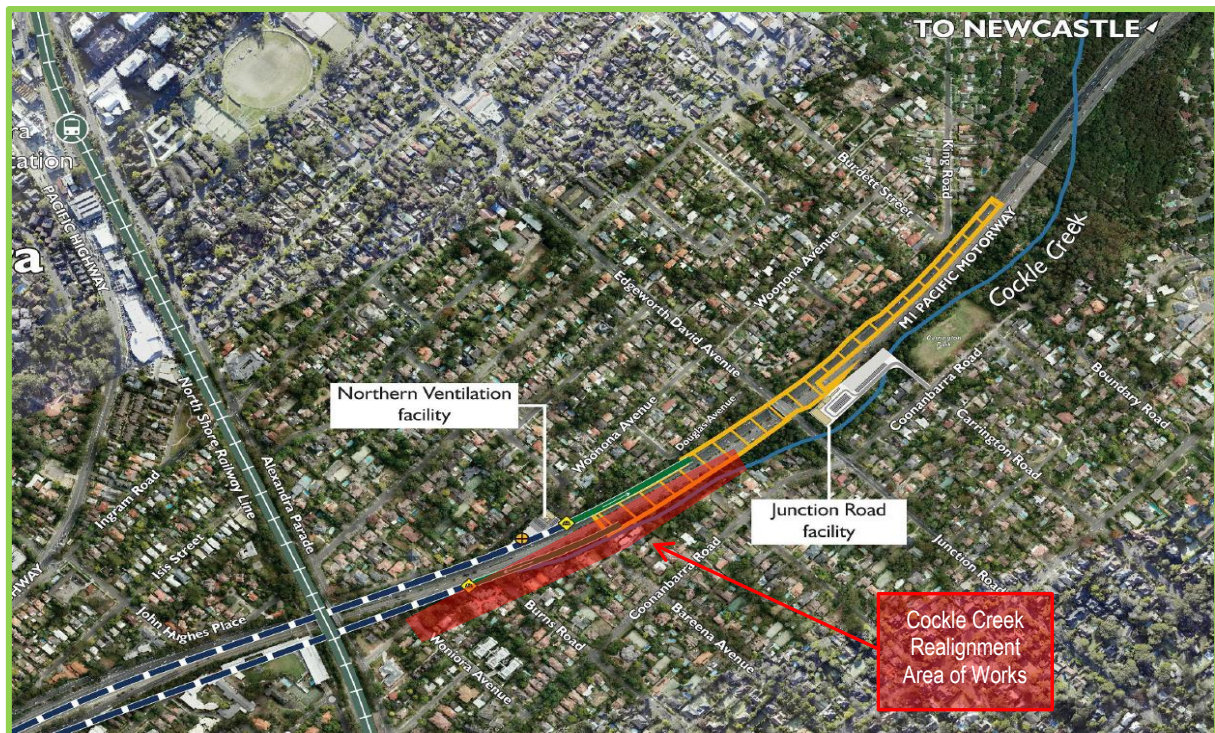
Figure 3: Close up of the northern civils package at Wahroonga, highlighting Cockle Creek along the southbound alignment of the M1 Pacific Motorway, and the realignment work area

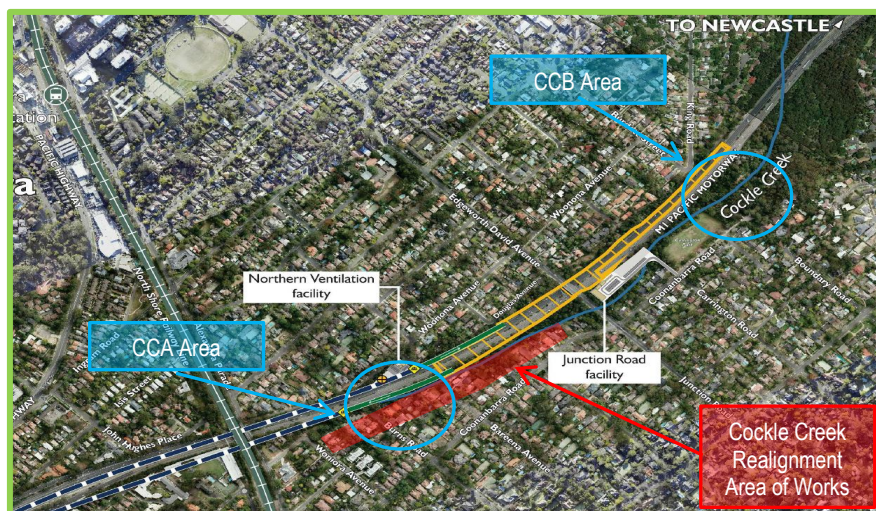
Figure 4: Rapid assessment of area CCA and CCB along the Cockle Creek alignment.

¹ Refer to CCA on Figure 4 for the location along the Cockle Creek alignment

² Refer to CCB on Figure 4 for the location along the Cockle Creek alignment

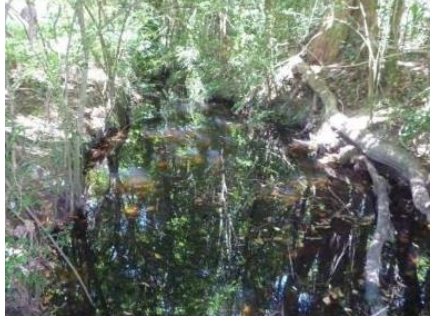
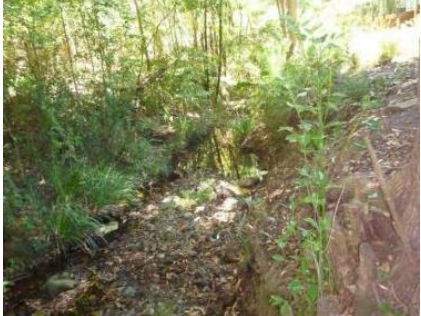
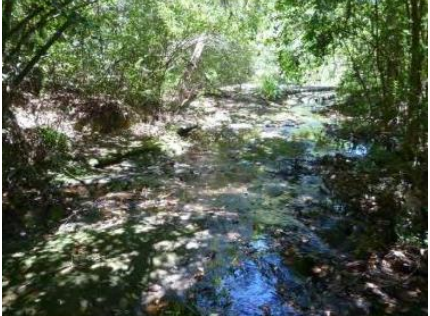
</div> <p>Reach CCA is in the vicinity of the Junction Road Compound (left), at Bareena Avenue (middle), and a steep rock drop-off downstream of Junction Road Compound (right).</p>

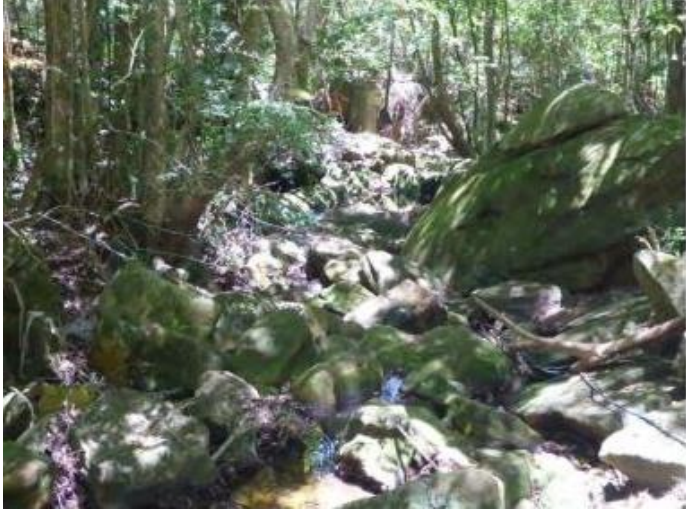
</div> <p style="text-align: center;">Reach CCB has boulders dominating the landscape downstream of Junction Road Compound (above).</p>

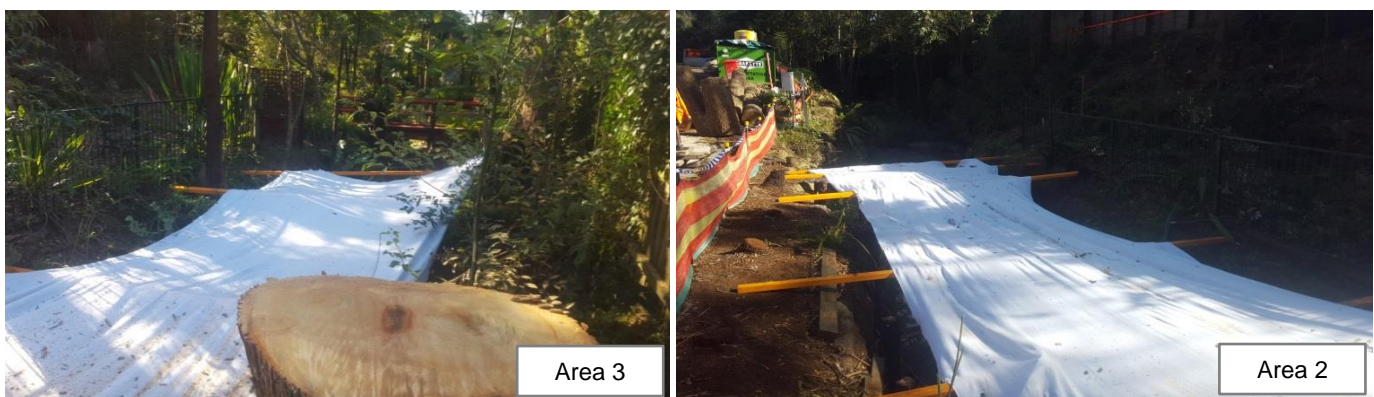
Photo 1 & 2: Timber frame with geo-fabric, to capture any debris during clearing activity

As clearing was being undertaken directly adjacent to Cockle Creek, specific environmental controls and measures were put in place to ensure no debris or saw dust would enter the live flow of water. Wood posts fitted with geo-fabric were installed along Cockle Creek within the active clearing area for that particular day (photos 1 and 2). The control was designed to capture all debris and saw dust generated from the clearing, preventing any foreign material from entering the clean water flows. This was a cost-effective approach, as all materials used were recycled from on-site and could be reused a third time following the clearing works. Where the wood frame could not be installed, a temporary diversion of the creek flow was set up, to redirect the water flow around the work area ensuring no debris would enter the live creek flow (temporary diversion described in detail in Stage 2).

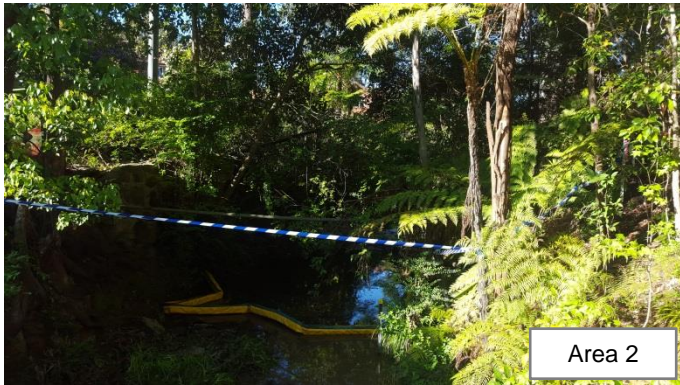
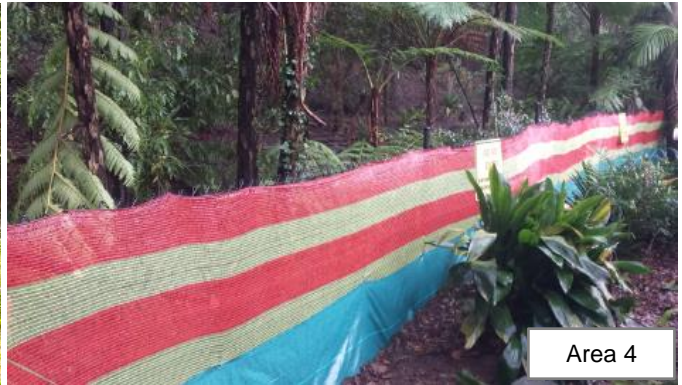
Photo 3 & 4: Clearing tape and sensitive area fencing delineating the vegetation area to be cleared, and the boom installed as secondary protection in the event of an environmental spill or additional debris

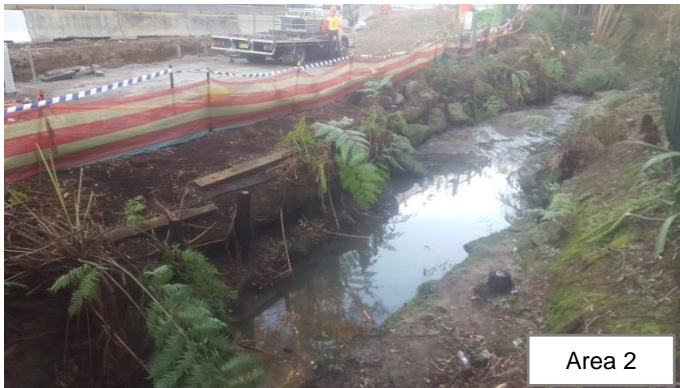
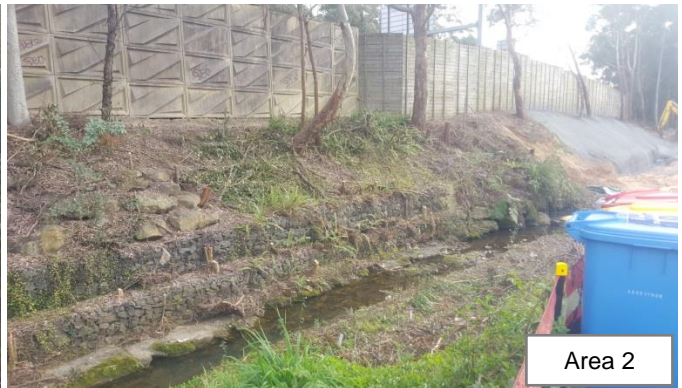
Photo 5 & 6: Area cleared, with the tree stumps and root zone remaining in place on the batters. Note the proximity of the noise wall of the M1 Motorway adjacent to the creek

The batters leading to the M1 Pacific Motorway on the western side of Cockle Creek were not grubbed during this stage of works, to ensure ground cover and stabilisation remained. The creek bed had some vegetation trimmed to allow access for detailed survey and geotechnical analysis, however was not grubbed to ensure no erosion or sedimentation potential (photos 3 to 10).

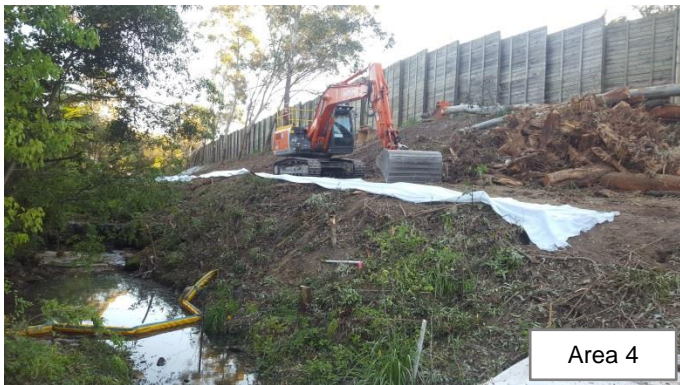
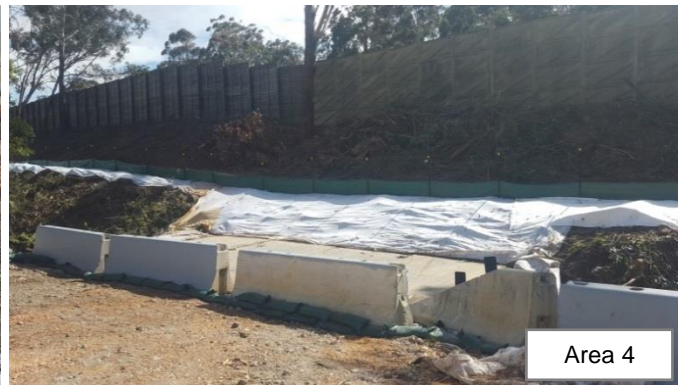
Photo 7: Commencement of installation of geo-fabric bunded batter along the western side of Cockle Creek, with marine boom installed as a precaution measure. Photo 8: Temporary crossing at Barena Avenue installed, with completed geo-fabric bund and sedimentation fence

Following clearing within the area, earth bunds or mulch bunds (mulch used from the clearing activity) secured with geo-fabric were installed along the alignment of Cockle Creek. Sediment fences were installed next to the bunds as a secondary ERSED defence (photo 8, 10).

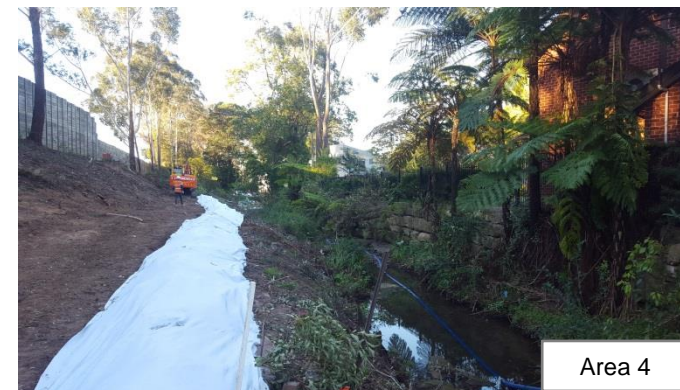
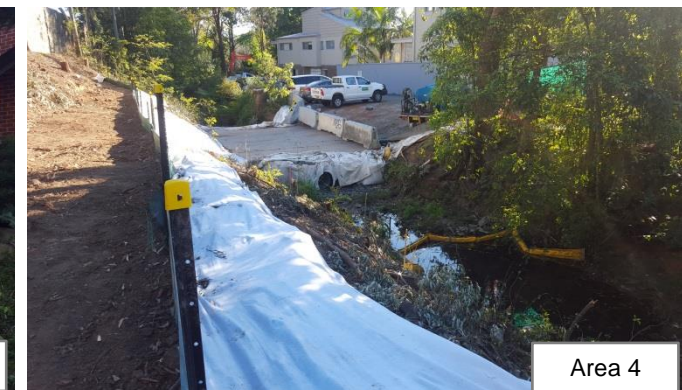
Photo 9 & 10: Clearing progressing on the western side of Cockle Creek, with ERSED controls being progressively installed

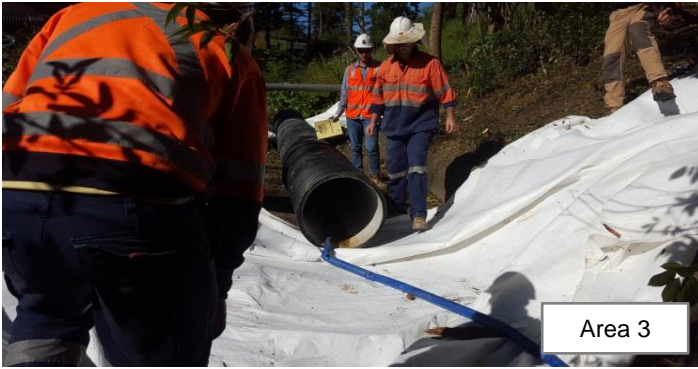
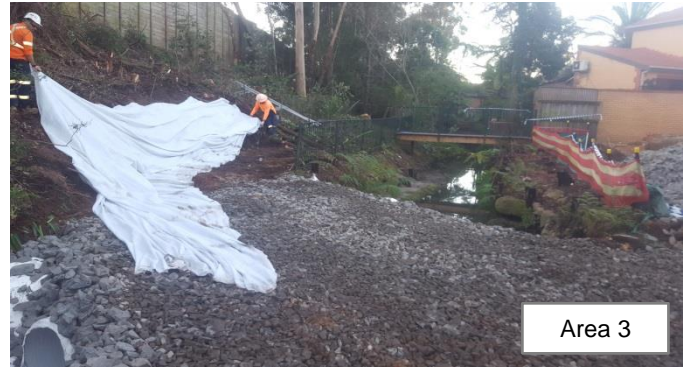
Photo 13: Temporary creek diversion in place whilst clearing the creek bed, placing geo-fabric, clean rock and pipes. Photo 14: Clean basalt rock placed on top of the temporary crossing and an additional layer of geo-fabric to secure the rock

Photos 11 to 16 below outline the process used to install a temporary creek crossing along the alignment of Cockle Creek. In this case, this crossing was installed at 2B Burns Road. This was installed for one week, prior to removing to allow the bulka bag realignment channel to be installed. This crossing was therefore considered very temporary, and hence sandbag walls within the temporary crossing were not installed.

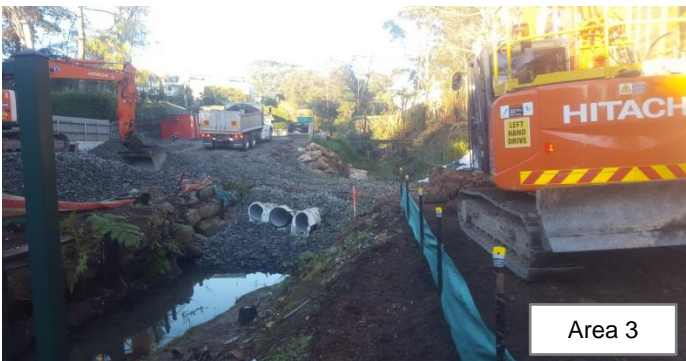
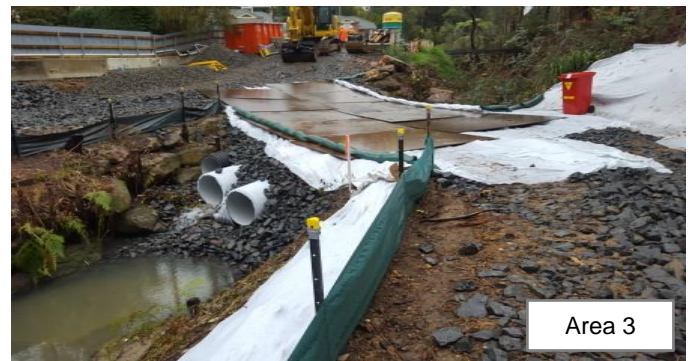
Photo 15: Steel plates removed over the crossing whilst plant travel across the crossing. Photo 16: ERSED controls set up around temporary crossing including a sediment fence, stabilised access on either side of the crossing and sandbag bunding

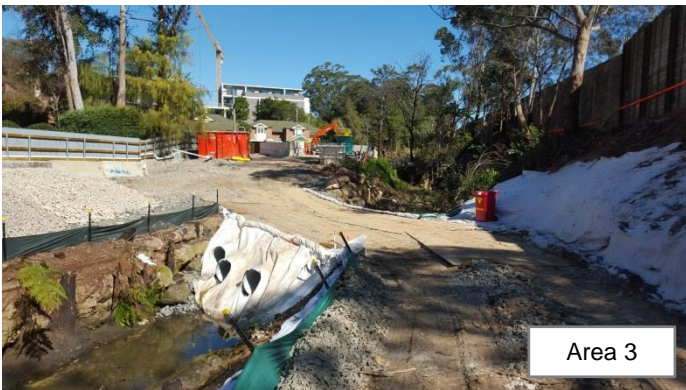
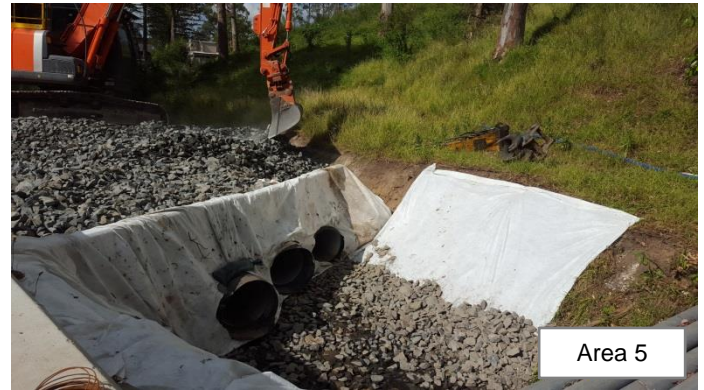
Photo 17: Temporary crossing installation. Photo 18: Installation of temporary crossing at Lochville Street, to attain access on the western side of Cockle Creek

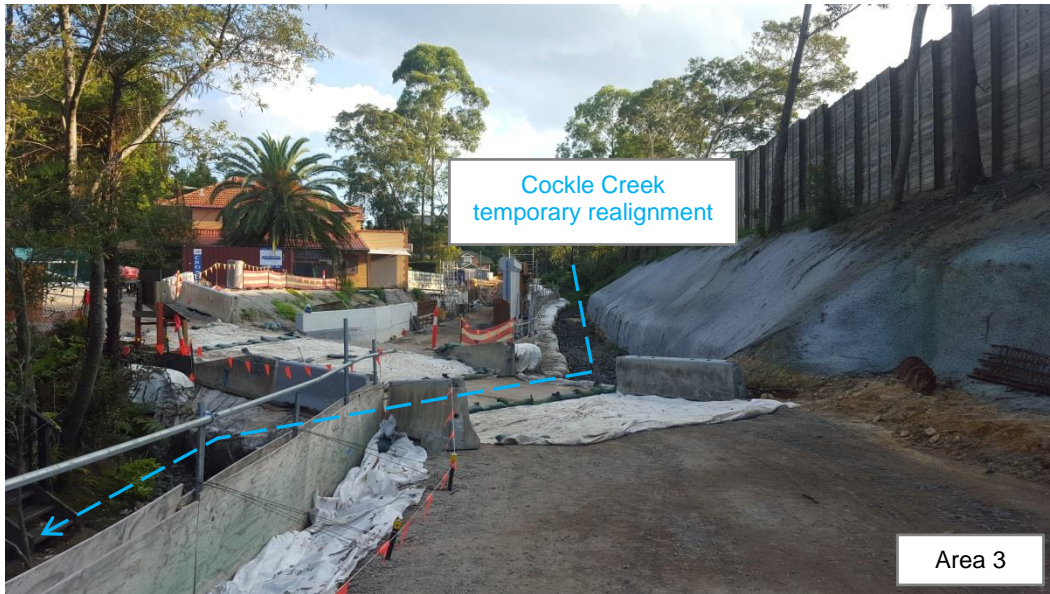
Photo 19: Temporary crossing at 2B Burns Road

Photos 19 to 21 show the completed temporary crossings at each location along Cockle Creek.

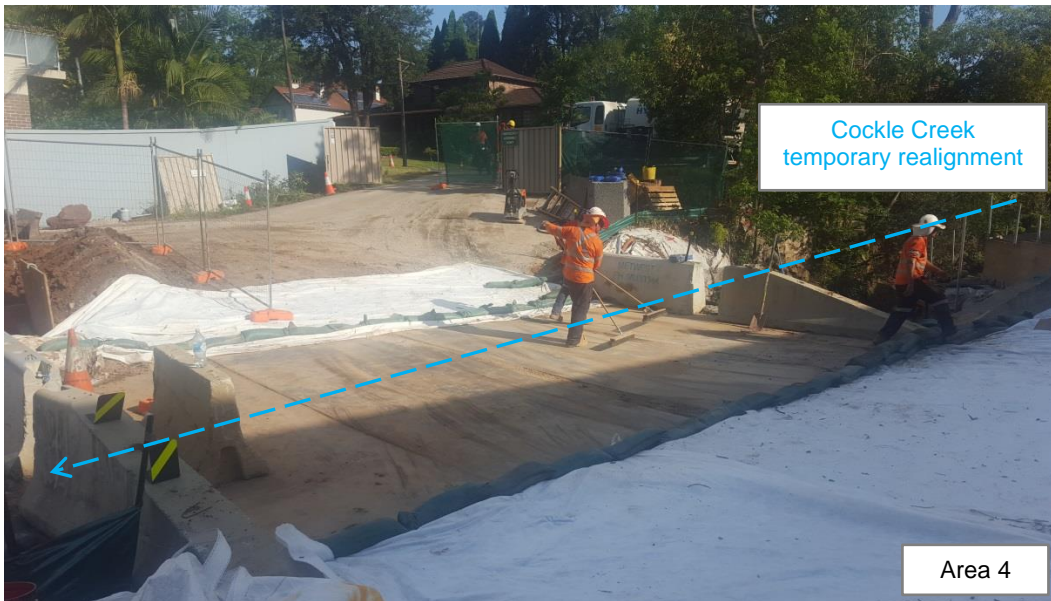
Photo 20: Temporary crossing at Bareena Avenue

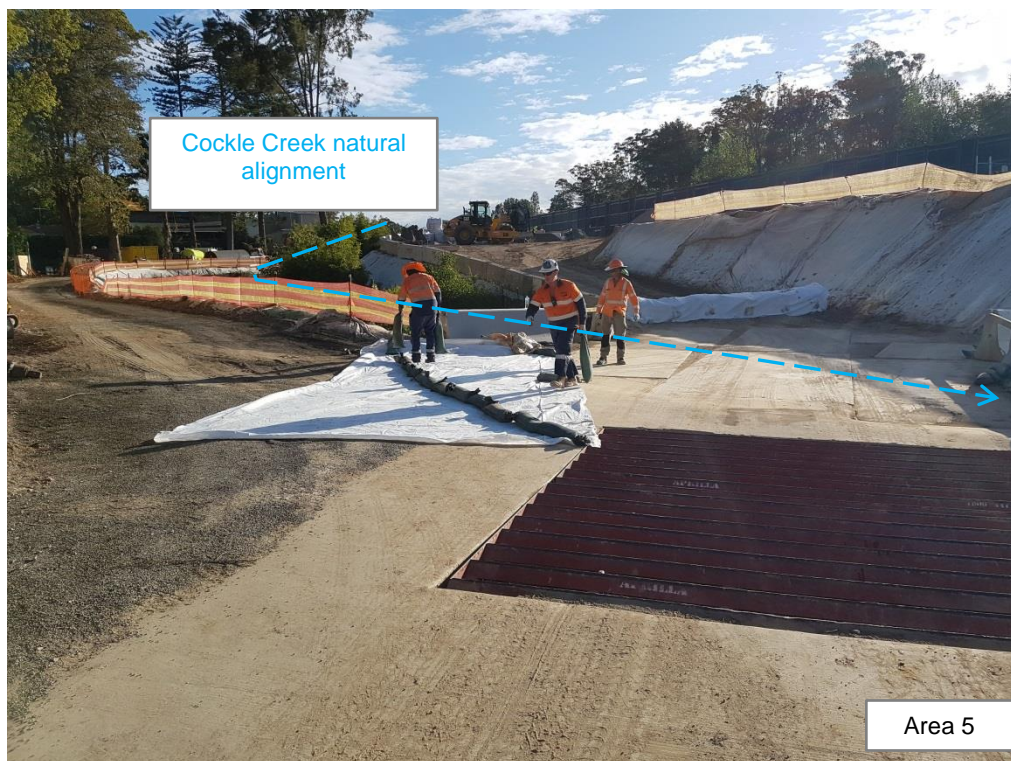
Photo 21: Temporary crossing at Lochville Street

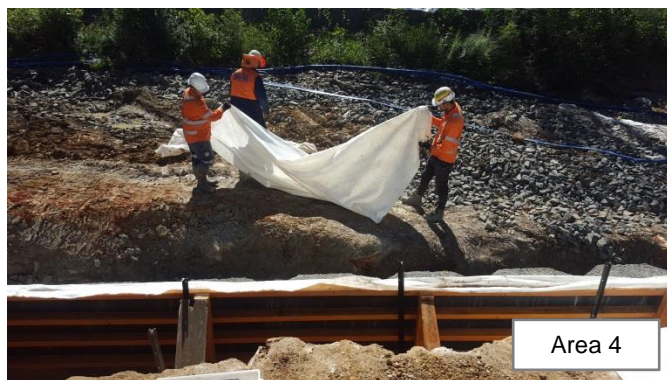
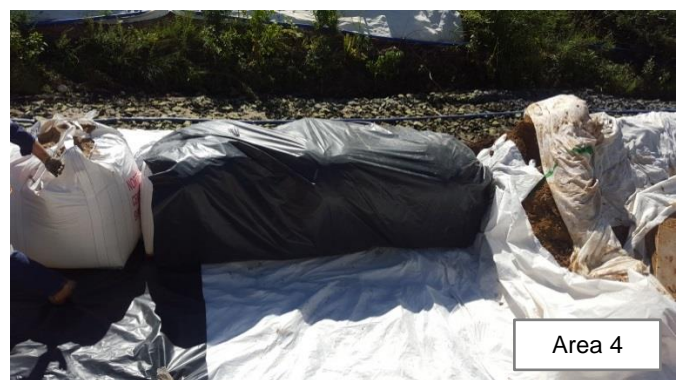
Photo 22 and 23: Temporary creek diversion is in place, whilst the creek bed has been excavated and the bulka bags are being installed, firstly wrapped in plastic and secondly with heavy duty geo-fabric. Note a small section of the creek bed has been excavated to ensure the construction activity is complete at the end of the shift, and to return natural the creek flows with no disturbance

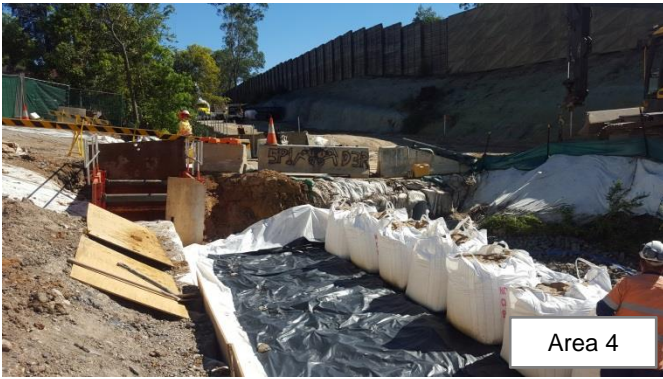
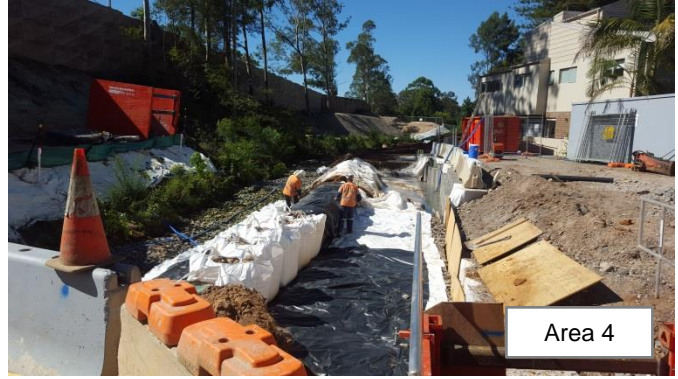
Photo 24 and 25: Small section of the creek bed at Bareena Avenue, with the bulka bags being installed progressively

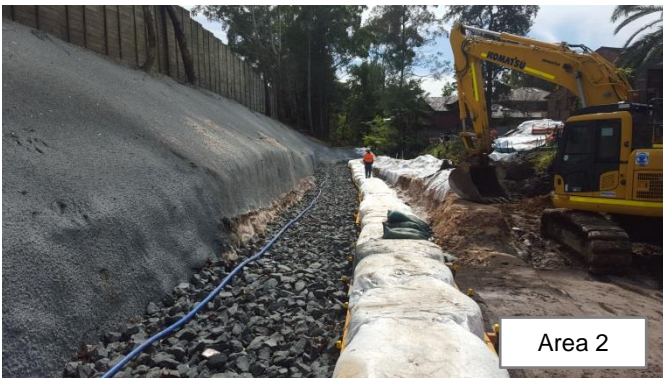
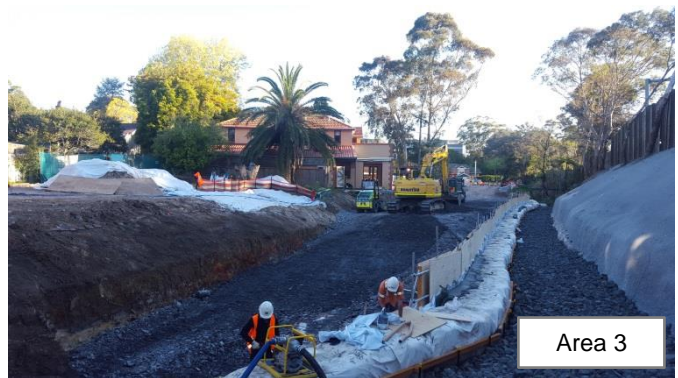
Photo 26: Section of the creek bed at Burns Road looking towards 2B Burns Road (north), where the creek bed has been excavated and bulka bags have been installed. A temporary creek diversion is in place (see the blue pipe), due to the excavation works being in close proximity. The batter has been shotcreted to limit the disturbance to the western side of the creek, and reduce maintenance (refixing/replacing geo-fabric).

Photo 27: Section at 2B Burns Road, with the progressive installation of the plywood fencing

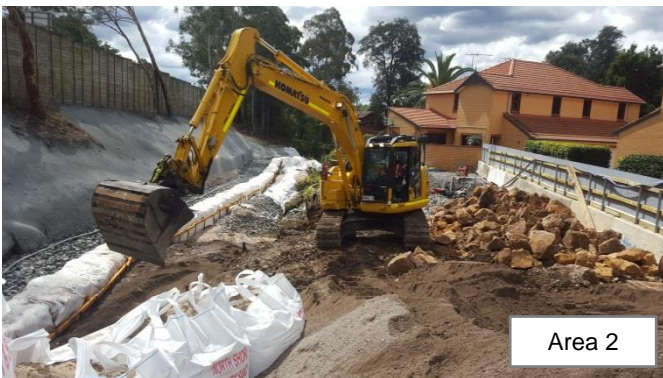
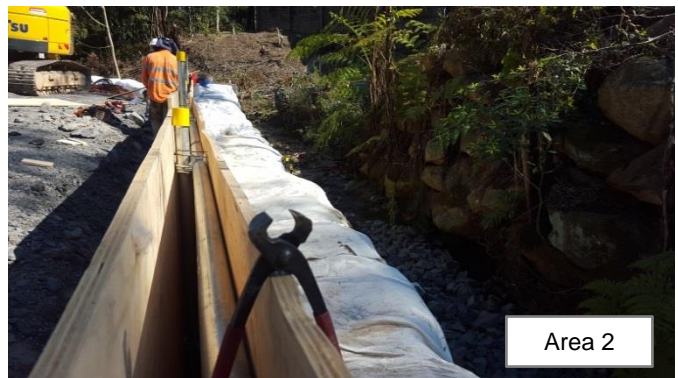
Photo 28: The existing creek bed is being backfilled in preparation for the installation of the plywood fencing. Photo 29: Installation of the plywood fencing.

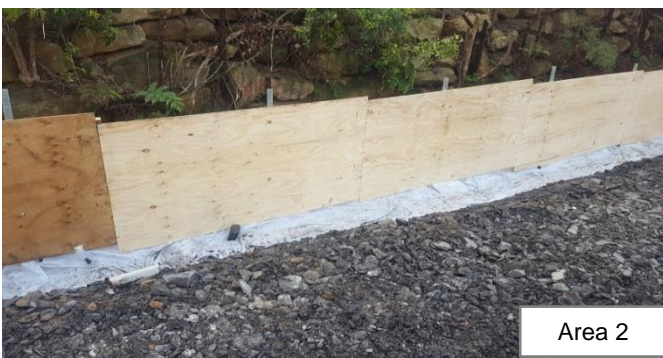
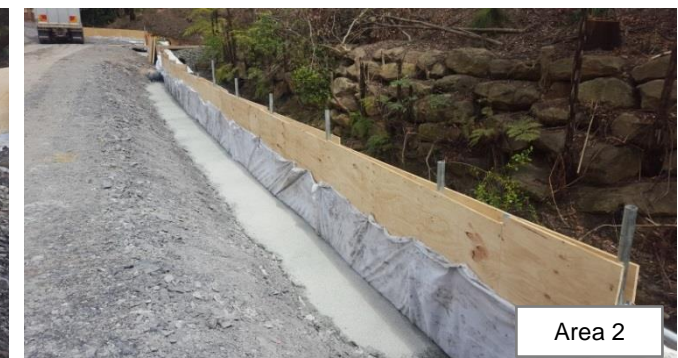
Photo 30 and 31: Completed plywood fencing with concrete backfill along the creek realignment, in preparation for the piling pad

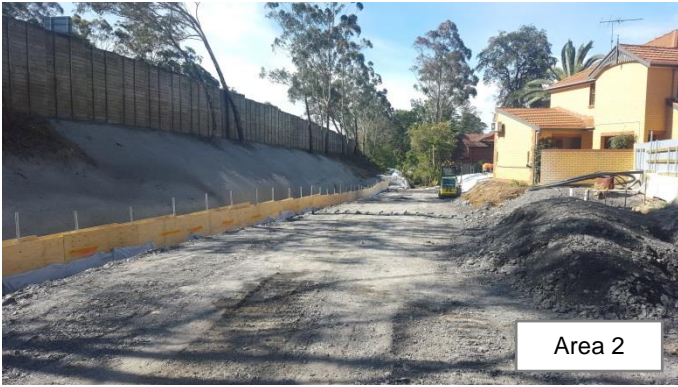
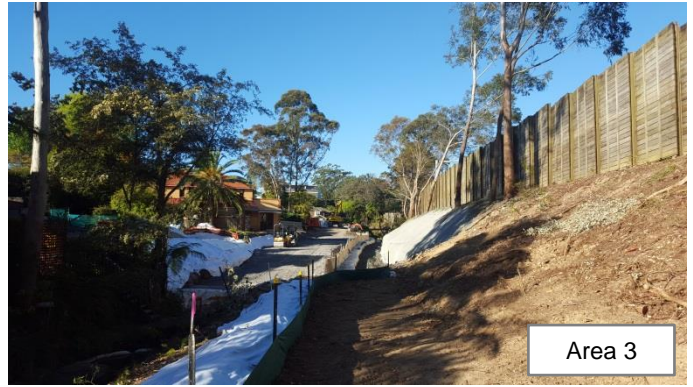
Photo 32: Completed plywood fencing and backfill for the piling pad, noting the sandbag breaks in place along the alignment to prevent potential erosion. Photo 33: View from 2B Burns Road looking southwards towards the completed temporary creek realignment

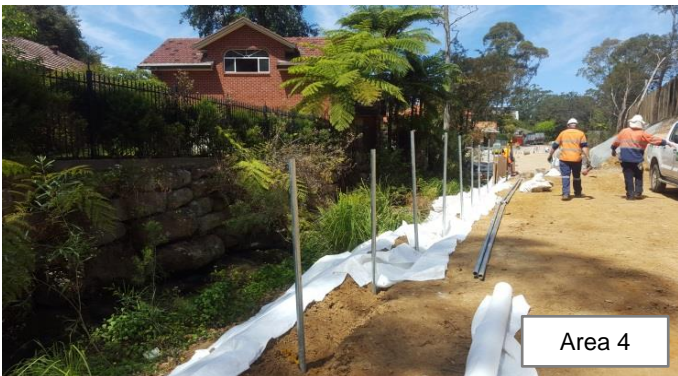
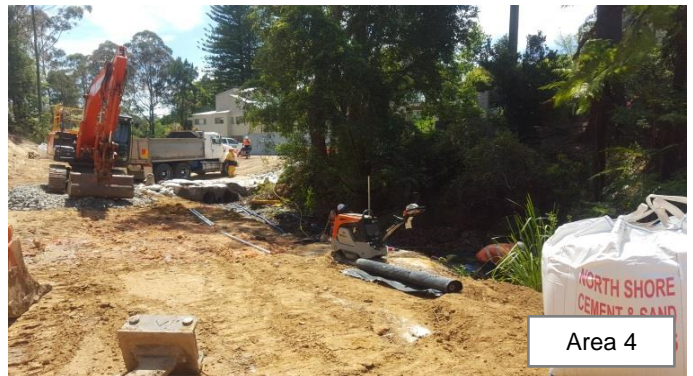
Photo 34 and 35: Installation of bulka bags in section of the creek between 2B Burns Road and Bareena Avenue, where the natural creek bed is unstable. Plywood fencing with concrete was installed as a protective measure for the creek, in preparation for the piling activity

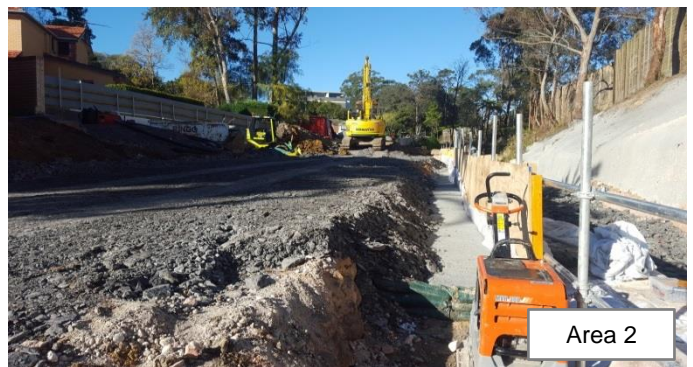
Photo 36: Shotcreted batter along the temporary creek alignment. Photo 37: Concrete poured behind the plywood fencing, with sandbag breaks installed along the alignment to capture any runoff from the piling pad

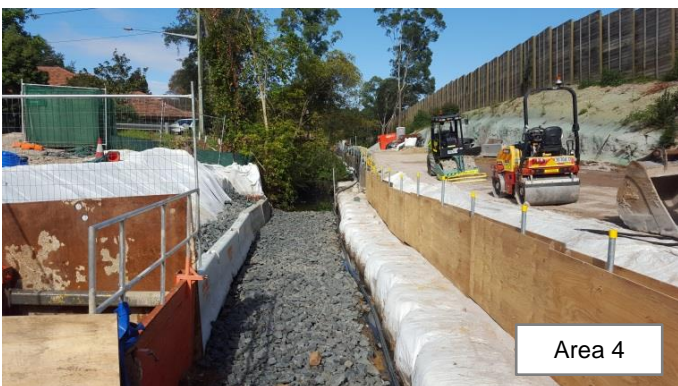
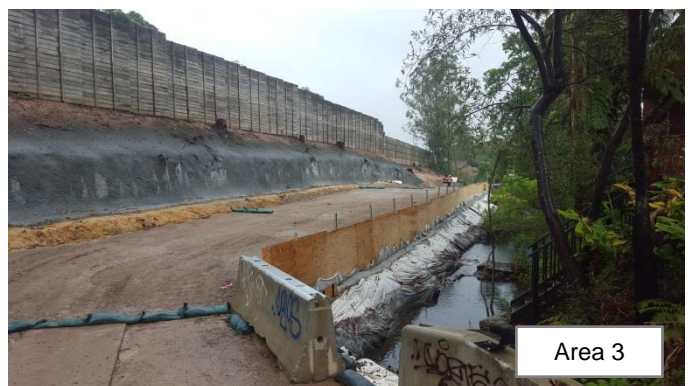
Photo 38: Section at Bareena Avenue realigned with bulka bag and plywood fencing installed. Photo 39: Temporary crossing at 2B Burns Road

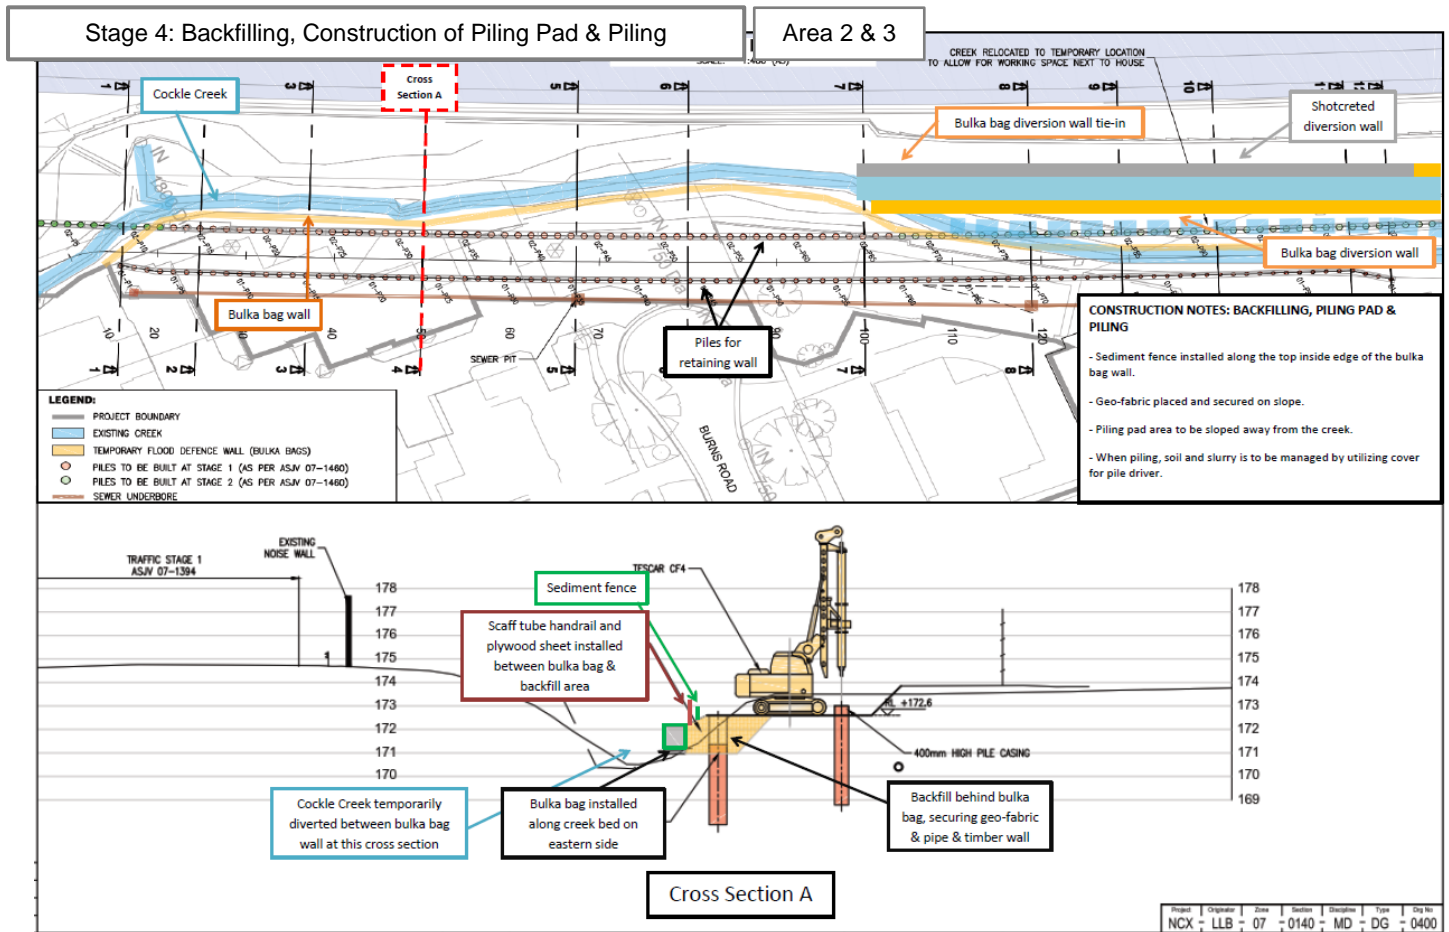
Figure 16: Extraction of ERSED Plan relation piling along Cockle Creek. Note the sediment fence was replaced with the installation of concrete poured behind the plywood fence to ensure no seepage through to the creek

The installation of more than 500 bored piles was required along the alignment of Cockle Creek, with multiple rows of piles extending from areas 1 to 5. When piling adjacent to Cockle Creek, additional controls measures were implemented, to ensure the waterway had adequate protection. This included the installation of plywood fencing, correctly managing the material from the bored piles and concrete pours, and setting up sedimentation tanks to pump any drill runoff into. Figure 16 below captures the piling activity and location along Cockle Creek.

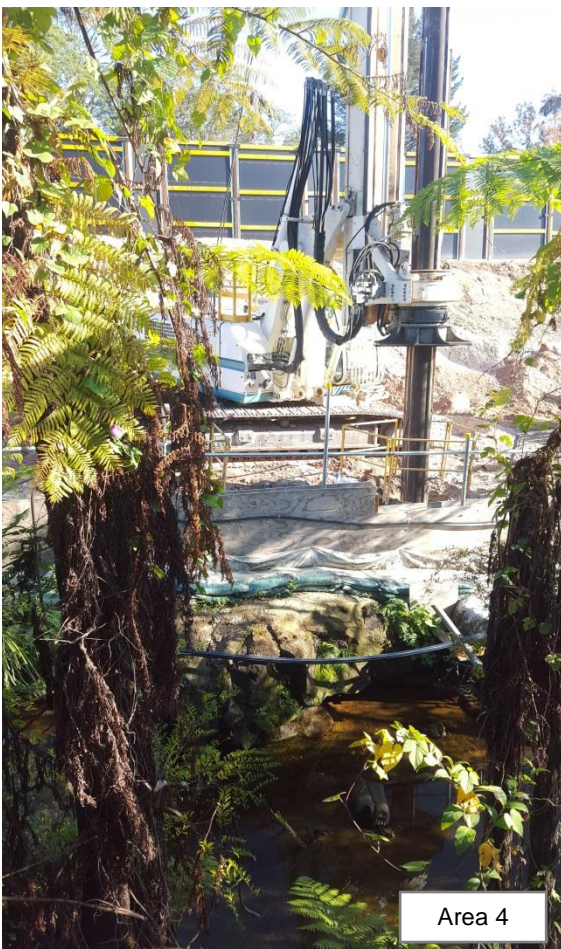
Photo 40: Piling along Cockle Creek

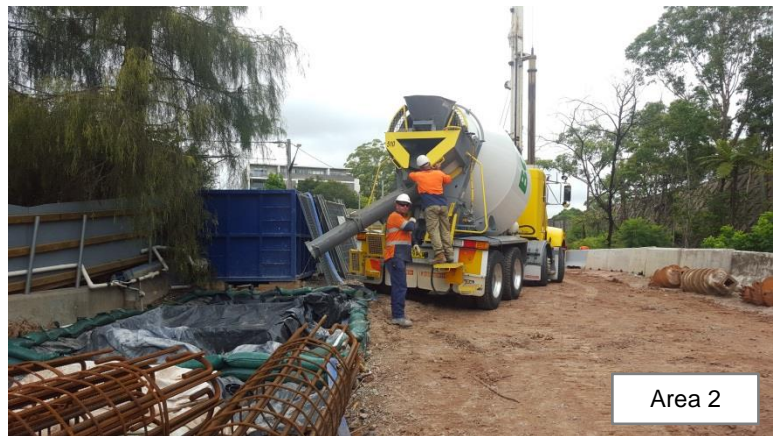
Photo 41: Concrete washout set up and positioned away from Cockle Creek, with sandbag bunding and plastic lining

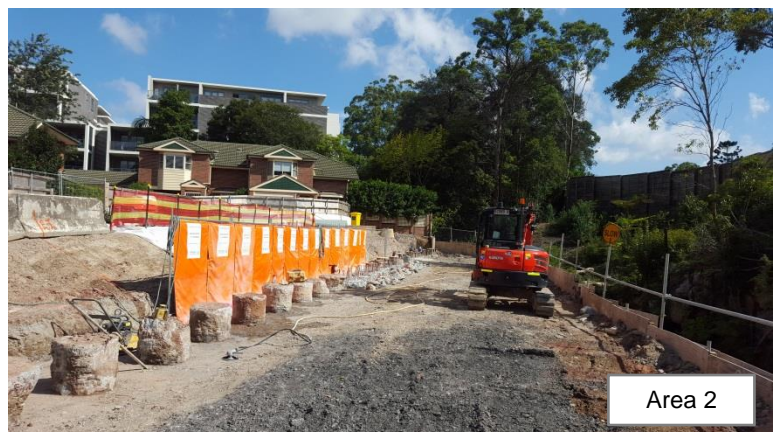
Photo 42: Pile trimming near Cockle Creek, with noise blankets set up

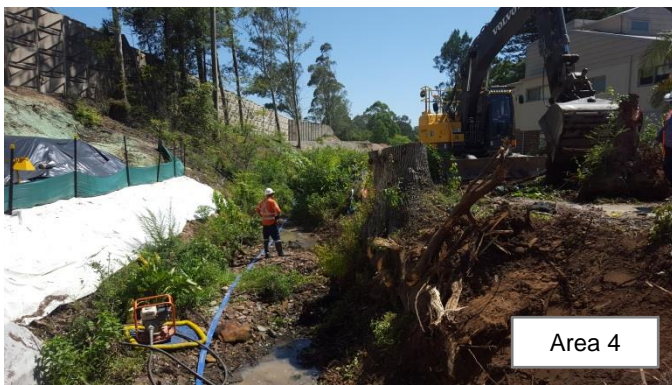
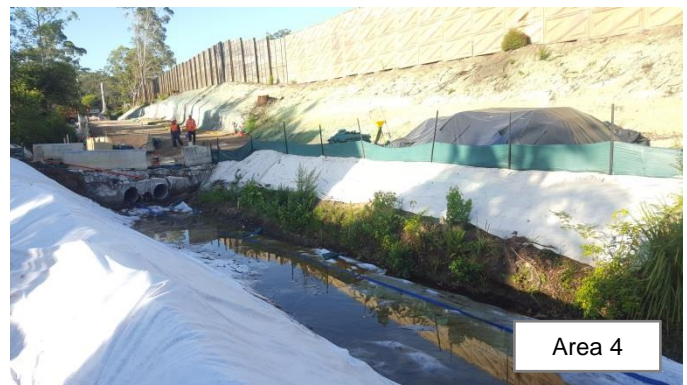
Photo 43: Clearing of tree stumps within the creek bed for the mass block wall installation. Photo 44: Heavy duty geo-fabric used as a temporary measure to stabilise the cleared creek banks, prior to the installation of the bulka bag and plywood fencing

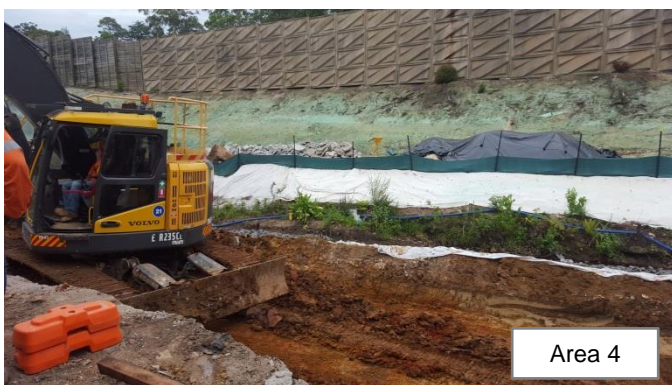
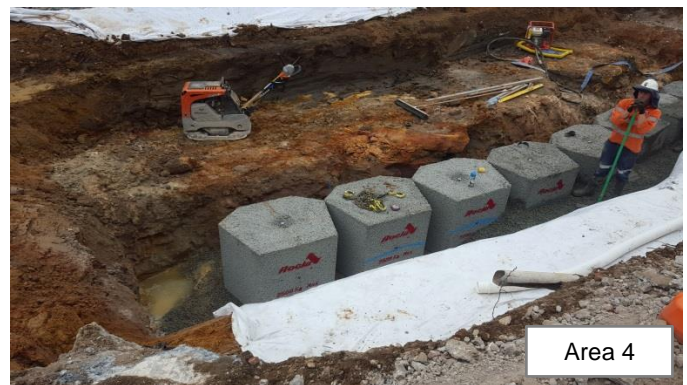
Photo 45: Excavation of the creek bed, for the installation of the mass block wall, noting a temporary creek diversion is in place to divert water around the work area. Photo 46: Commencement of installation of mass blocks

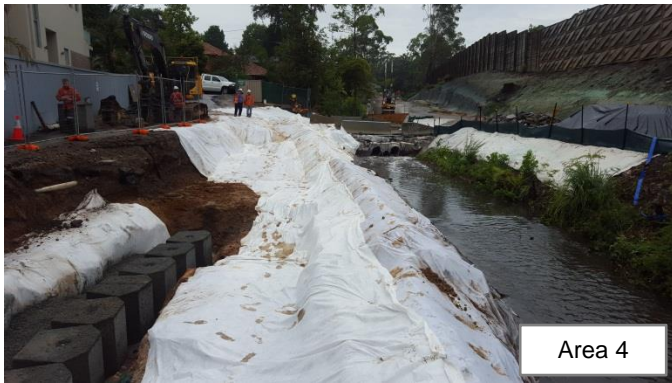
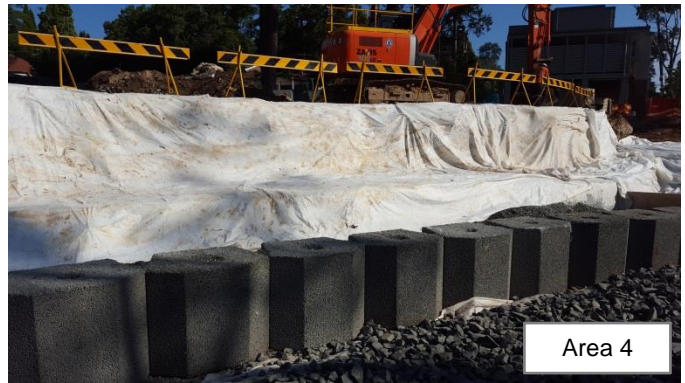
Photo 47: Area 4 during a rain event, with the site team installing heavy duty geo-fabric along the creek bank and around the mass block wall area. Photo 48: Section of mass block wall completed, with geo-fabric lined batter and installation of clean basalt rock in the creek channel

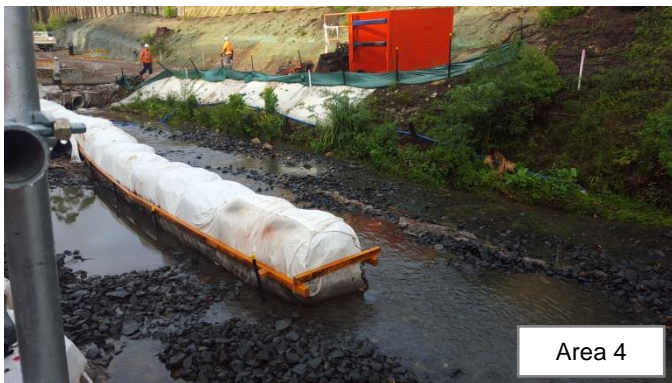
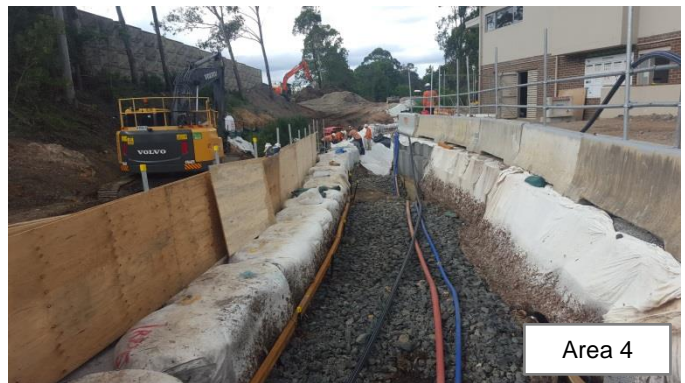
Photo 49: Commencement of installation of bulka bag wall for the creek realignment, following a rain event. Photo 50: Installation of bulka bag and plywood fencing along area 4, during a temporary creek diversion around the works (the 3 pipes along the rock)

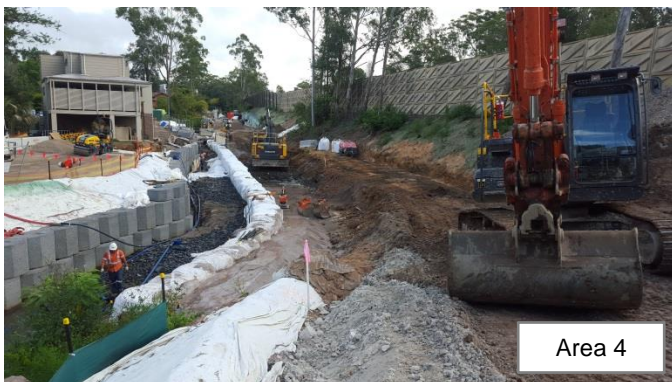
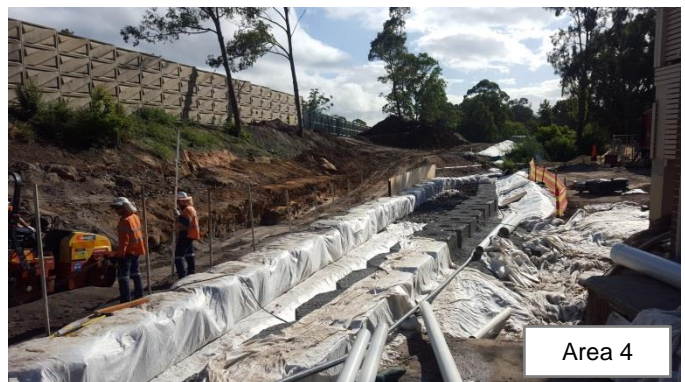
Photo 51 & 52: Continued installation of the bulka bags and plywood fencing, in preparation for the piling pad and piling works

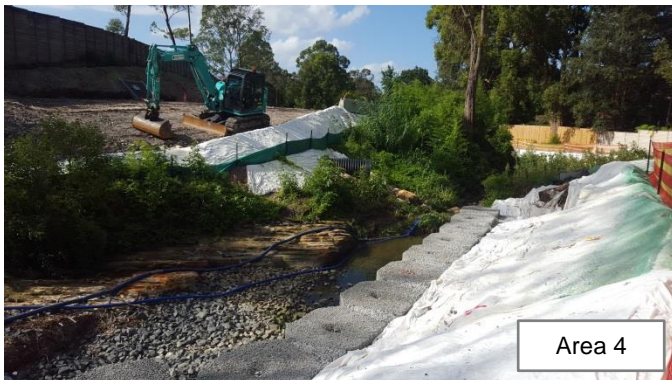
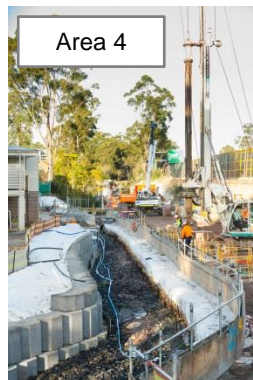
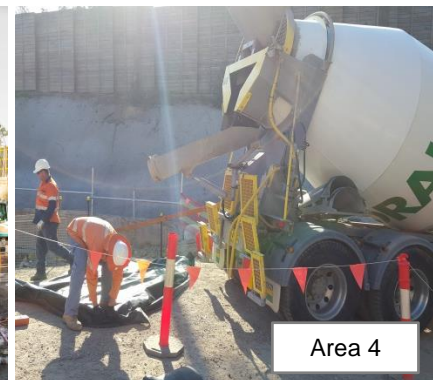
Photo 53: Extension of mass block wall, and piling pad preparation. Photo 54: Piling commencement following the installation of bulka bags and plywood fencing. Photo 55: Concrete management during the installation of the plywood fencing and mass block wall

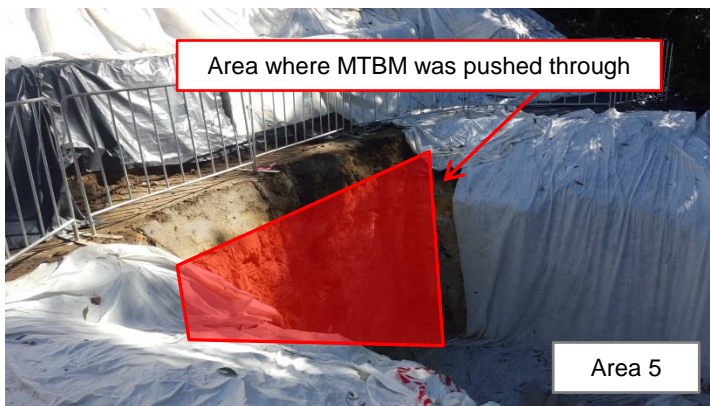
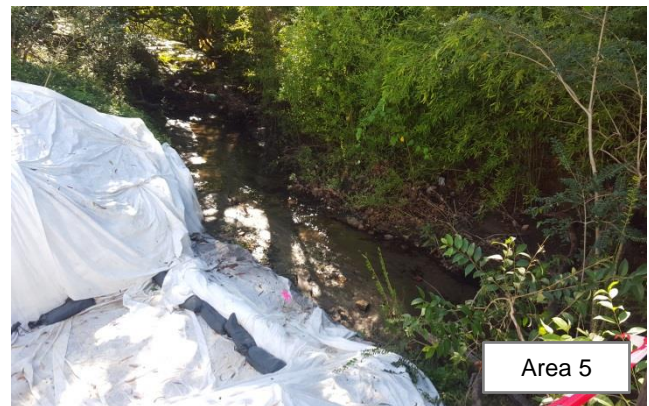
Photo 56 and 57: Proximity of the underbore receiving pit to Cockle Creek

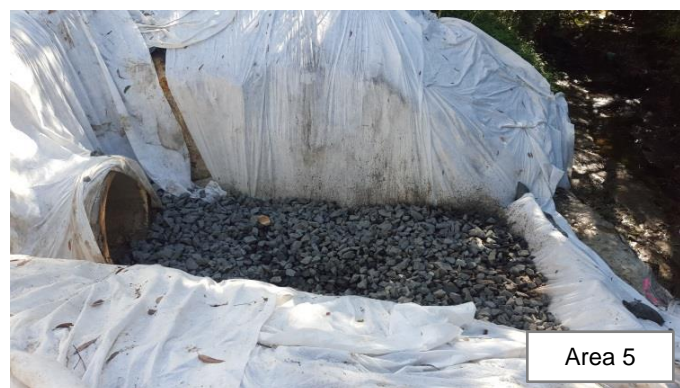
Photo 58: Additional geo-fabric and basalt rock placed in preparation for the connection

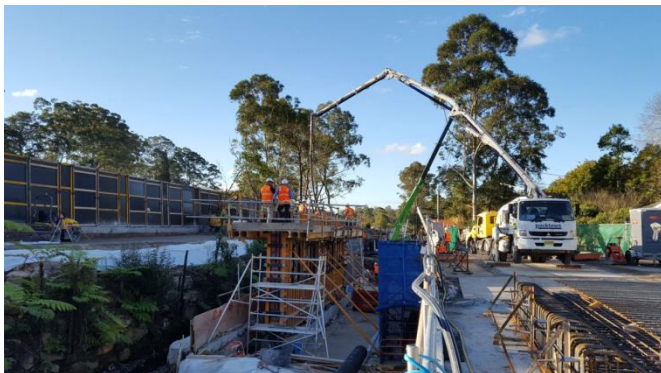
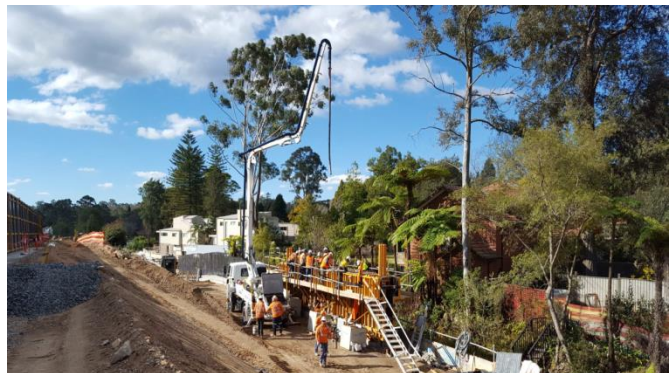
Photo 59 and 60: Concrete pour with a concrete pump into various sections of retaining wall 2

The temporary crossing installed at 2B Burns Road needed to be removed in order to enable pouring the retaining wall adjacent to the temporary creek realignment. Once removed, concrete pours for sections of the retaining wall were undertaken, measuring 15m³ to 20m³ in size (size of each pour required).

As the concrete pours were considered large, and multiple deliveries were required, careful planning was required to ensure the appropriate environmental controls were in place. Upon delivery of the concrete, the concrete agitator was set up on the eastern side of the creek where protection from the bulka bag and plywood fencing was located, and temporary bunding was provided between the pump and agitator truck (using material such as geo-fabric or left over plastic from the bulka bag wall installation). The concrete pour was undertaken on retaining wall 1, where the cycleway and noise walls were erected. When pouring concrete, it was ensured that there was a designated concrete washout area with adequate environmental controls protecting the area in the event of a spill or rain. The below photos capture the typical concrete delivery and washout setup. Any potential ground water pushed to the top of the surface during the pour was pumped into the detention tank, which was checked for adequate capacity prior to pouring the wall. Any excess concrete over-poured above the designed finish level was transferred into the designated concrete washout bin. This process was repeated for each pour for each section of the retaining wall.
