NorthConnex

2018 IECA Environmental Excellence Award

The \$3 billion NorthConnex project will deliver significant benefits to road users across Sydney, with the opening of the twin nine-kilometre tunnels expected in 2020. NorthConnex is the longest road tunnel project in Australia, and will link the M1 Pacific Motorway at Wahroonga to the Hills M2 Motorway at West Pennant Hills. The tunnel will remove around 5,000 trucks daily from Pennant Hills Road, helping to improve safety, local air quality and reduce existing traffic noise. The project is being delivered by Lendlease Bouygues Joint Venture on behalf of the proponents Transurban and Roads and Maritime Services with the tunnel to be operated and maintained by NorthConnex Company Pty Ltd (consisting of Transurban and the Westlink M7 shareholders).

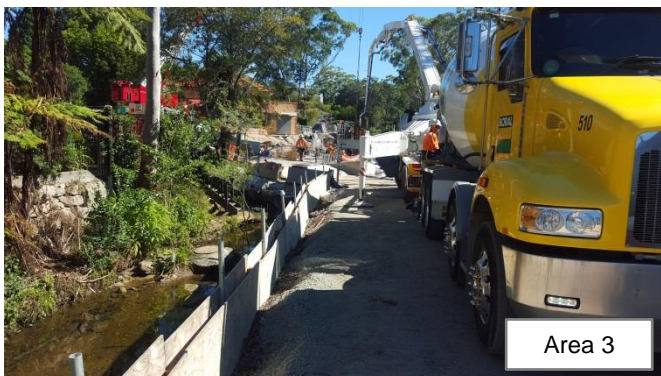
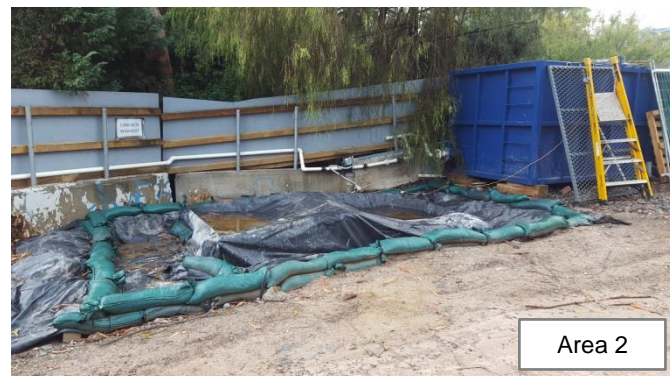
Photo 61 and 62: Concrete delivery and washout set up along Cockle Creek for the retaining wall pours

As the concrete pours were considered large, and multiple deliveries were required, careful planning was required to ensure the appropriate environmental controls were in place. Upon delivery of the concrete, the concrete agitator was set up on the eastern side of the creek where protection from the bulka bag and plywood fencing was located, and temporary bunding was provided between the pump and agitator truck (using material such as geo-fabric or left over plastic from the bulka bag wall installation). The concrete pour was undertaken on retaining wall 1, where the cycleway and noise walls were erected. When pouring concrete, it was ensured that there was a designated concrete washout area with adequate environmental controls protecting the area in the event of a spill or rain. The below photos capture the typical concrete delivery and washout setup. Any potential ground water pushed to the top of the surface during the pour was pumped into the detention tank, which was checked for adequate capacity prior to pouring the wall. Any excess concrete over-poured above the designed finish level was transferred into the designated concrete washout bin. This process was repeated for each pour for each section of the retaining wall.

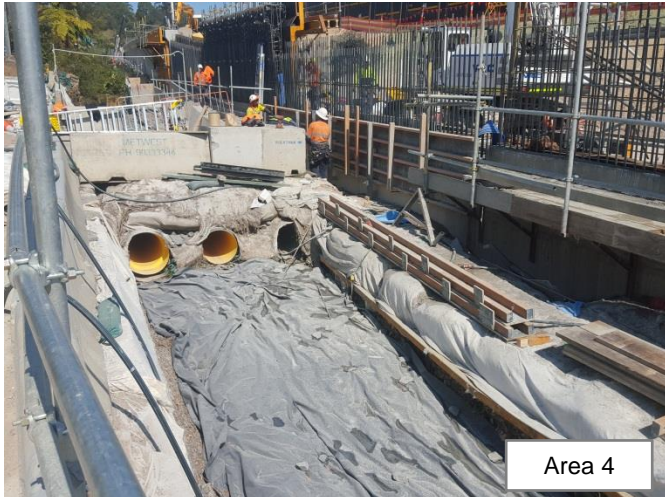
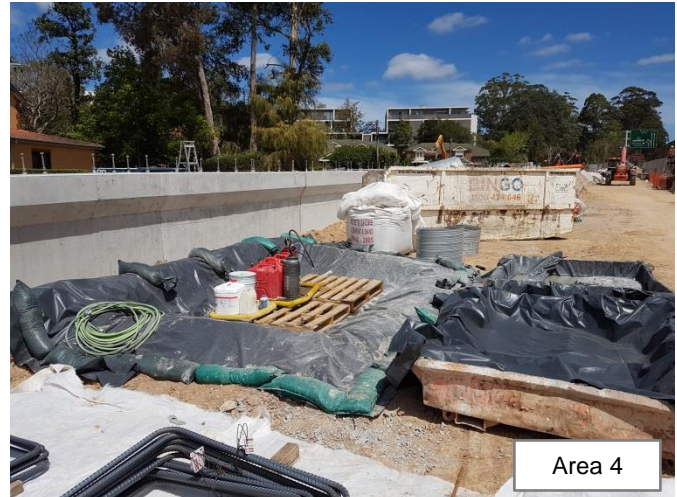
Photo 63: Temporary diversion set up directing the clean water flows of Cockle Creek around the area to be poured. Plastic lining is placed over the creek to ensure any spills or overpours are captured. Photo 64: Concrete washout and chemical bunding in preparation for a concrete pour

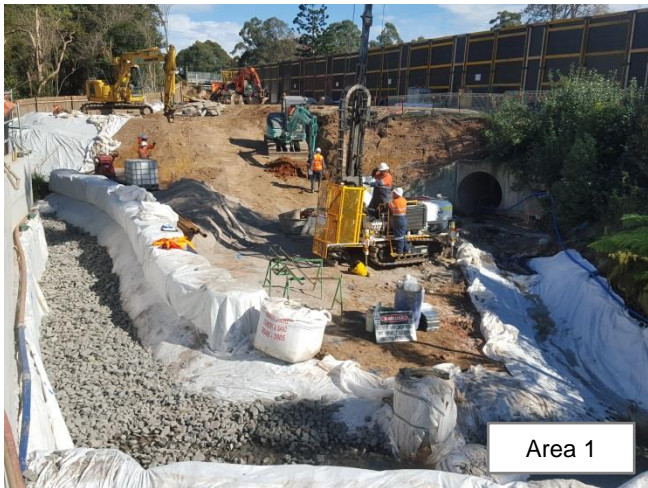
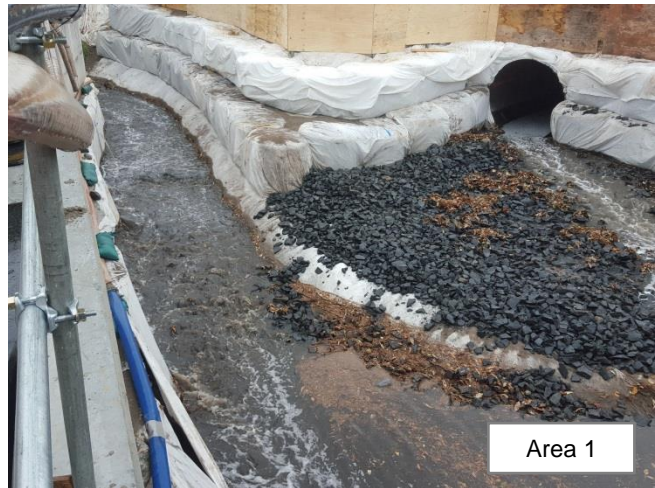
Photo 65: Cockle creek temporarily realigned around the piling and soil anchor works. Photo 66: Cockle Creek following a rain event

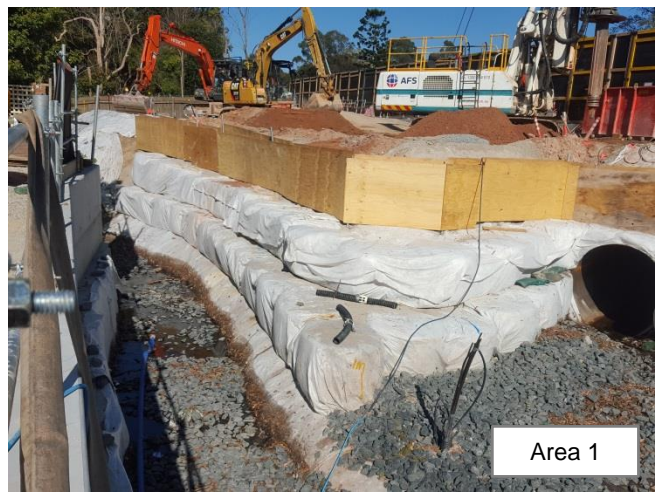
Photo 67: Section of cockle creek with piled retaining wall 01 in the background. Photo 68: Soil anchors installed in the creek area

The installation of 10m long soil anchors underneath the new creek alignment was required at the southern end of Cockle Creek, in the area of the M120 portal. Due to the restriction in location and proximity to the creek, the existing bulka bag and plywood fencing between the existing creek alignment and the new creek alignment was removed to allow the installation. The ground level that the anchors needed to be installed from was below the adjacent existing creek level and needed to be excavated out. In order to maintain clean water flows along the creek, and prevent any water from entering the work area, a low flow pipe system and diversion channel was installed.

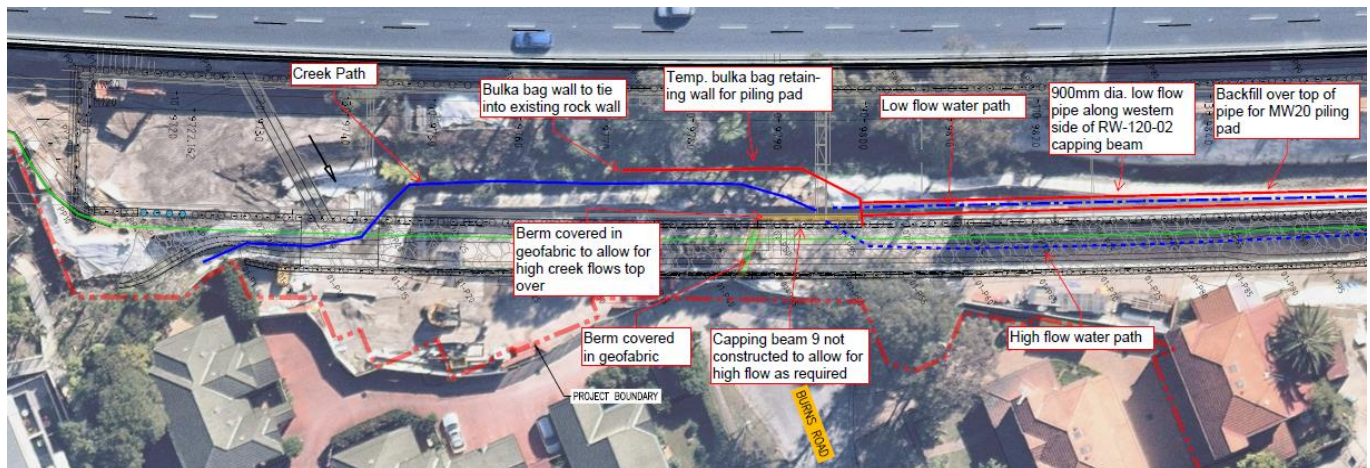
Figure 21: Environmental controls and work method for realignment of Cockle Creek behind retaining wall 2

Figure 21 below outlines where the creek was realigned, and the controls required to ensure clean water flows were maintained and protected from the construction activity in the surrounding areas. The photos visualise the temporary realignment behind the retaining wall.

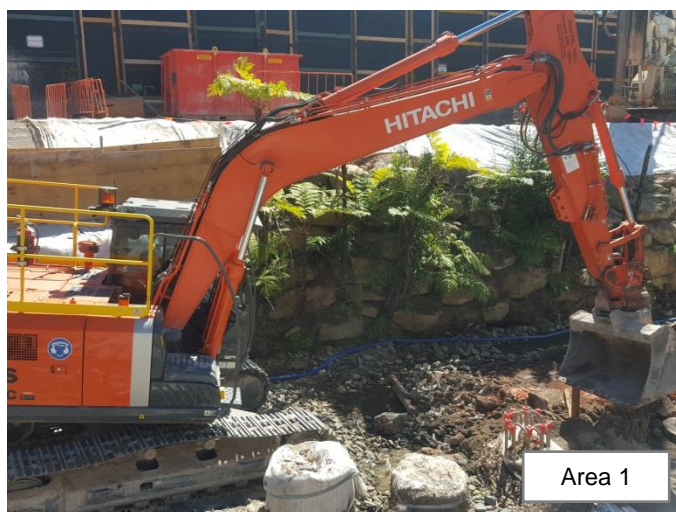
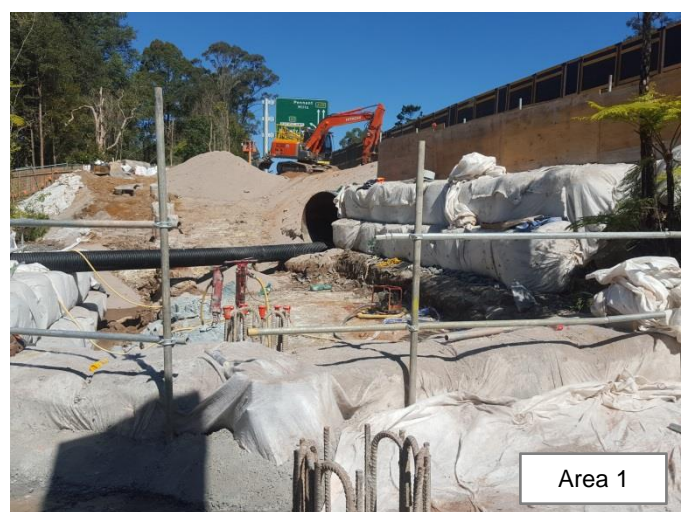
Photo 69: Excavation behind the piles for retaining wall 2, in preparation for the temporary realignment of Cockle Creek. Note the temporary diversion in place directing the clean water flows of Cockle Creek around the work area. Photo 70: Extension of the 1800 pipe outlet at the portal, and the bulka bags acting as the protective barrier for the creek

Following the installation of the soil anchors within the M120 portal area, the final piles for the portal structure were poured, retaining wall 2 was poured and an additional realignment of Cockle Creek was required to enable further access around the creek area, for further concrete pours, and work to build the permanent channel between the two retaining walls. The temporary realignment of Cockle Creek was directed on the western side of retaining wall 02, in a geo-fabric and clean basalt rock low flow channel, and surface water concrete channel. The 1800 pipe outlet within the portal area was temporarily extended over the work area and into the creek.

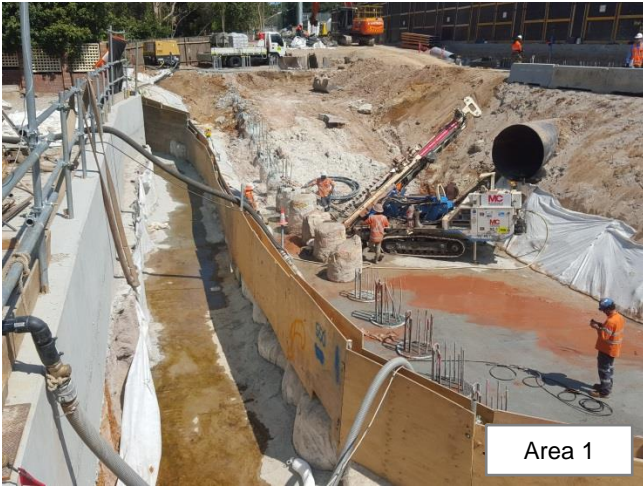
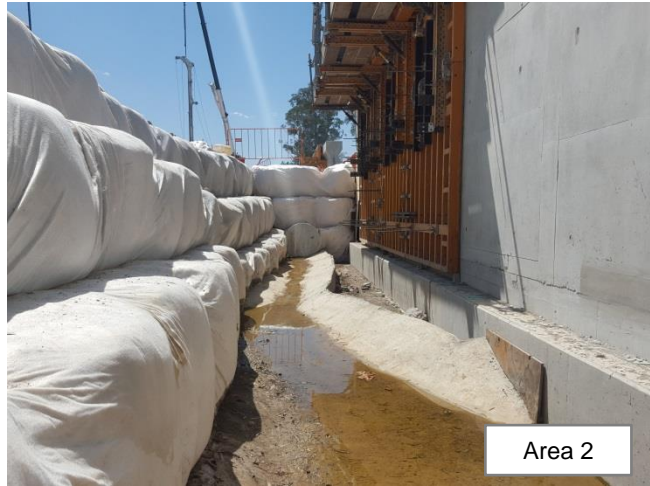
Photo 71: Temporary realignment of Cockle Creek around the piling works at the M120 portal. Photo 72: Temporary realignment of Cockle Creek behind the retaining wall, with the surface water channel being concreted and the low flow channel in place

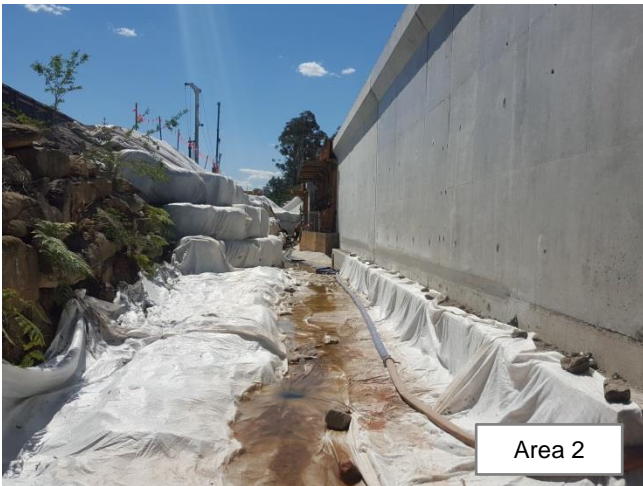
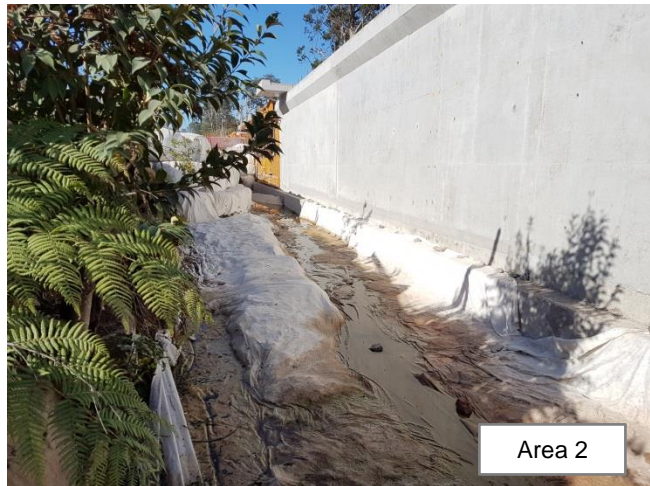
Photo 73 & 74: Temporary realignment of Cockle Creek behind retaining wall 02, with geo-fabric and clean basalt rock lining. Note the pipe is set up but not in use for a temporary diversion

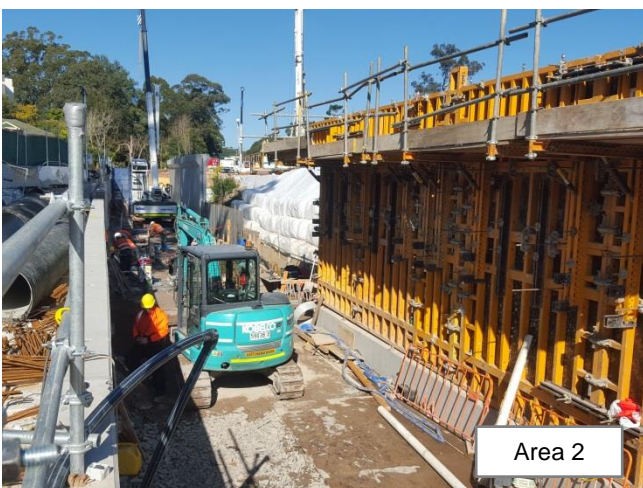
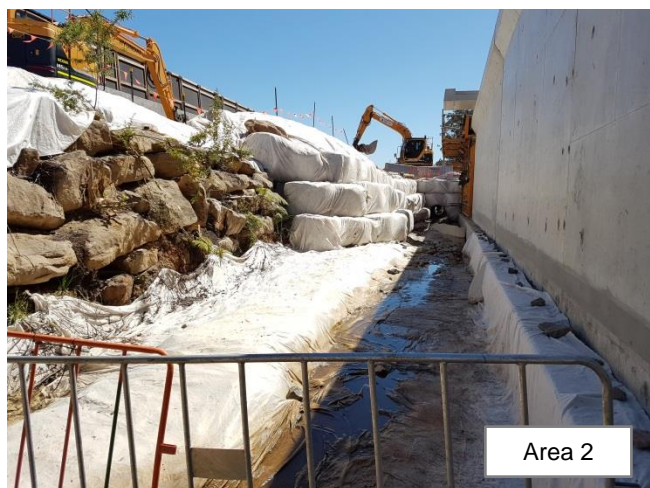
Photo 75: Permanent works occurring along the channel between retaining walls one and two. Photo 76: Temporary realignment of Cockle Creek

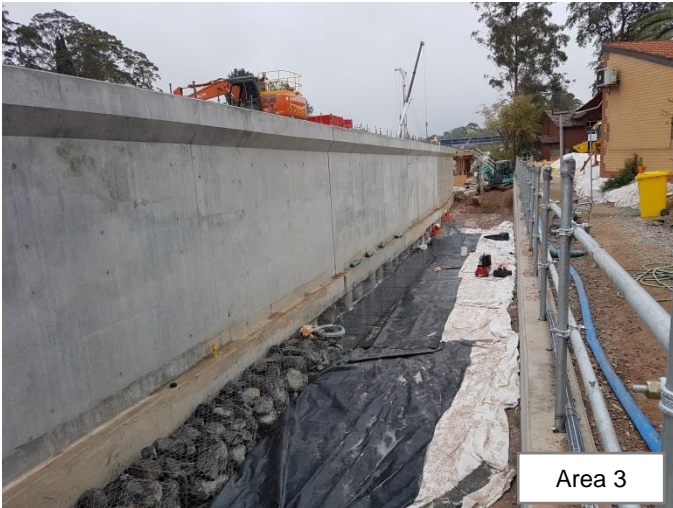
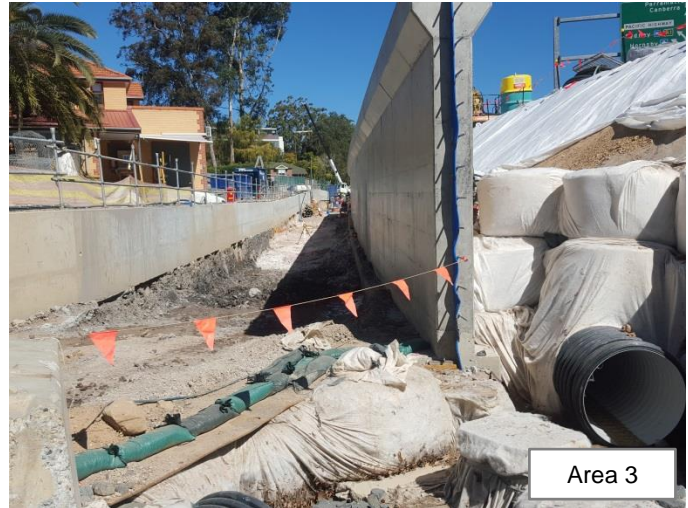
Photo 77: Permanent channel works, including regrading and construction of a low flow channel, geo-fabric and plastic lining, and gabion basalt rock baskets. Photo 78: Outlet of the temporary realignment channel at 2B Burns Road. The section had to be piped due to the construction of a piling pad

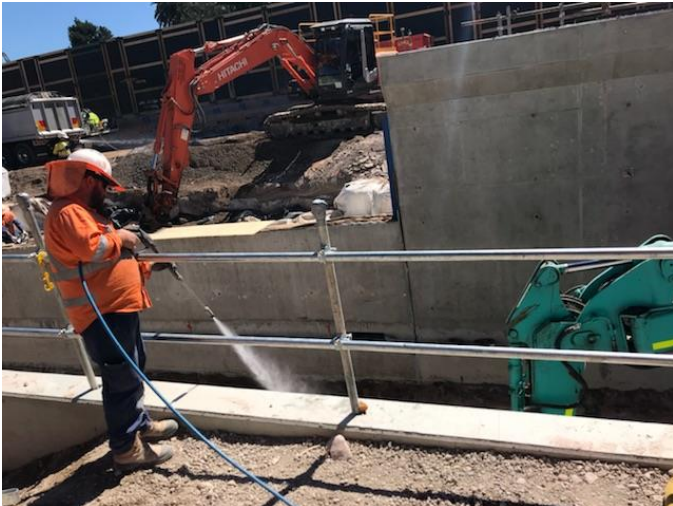
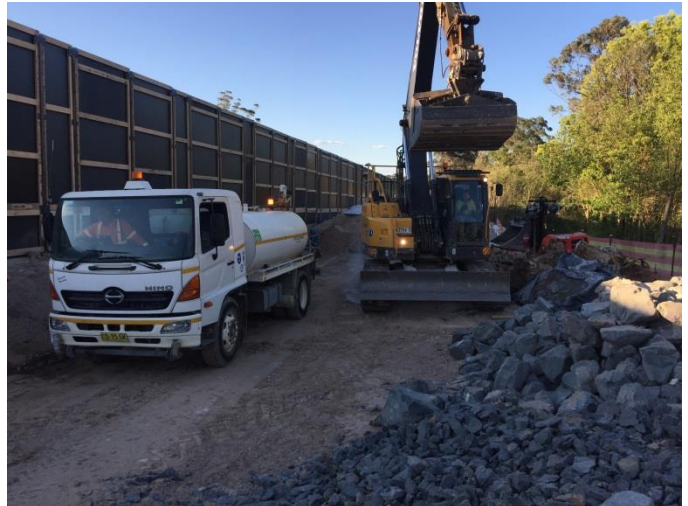
Photo 79 & 80: Dust suppression during various construction activities along Cockle Creek

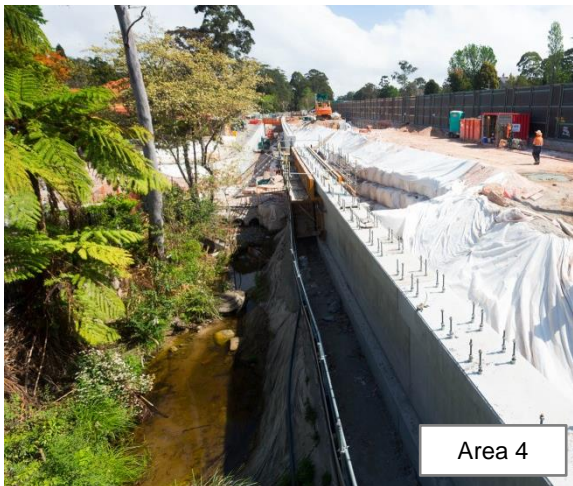
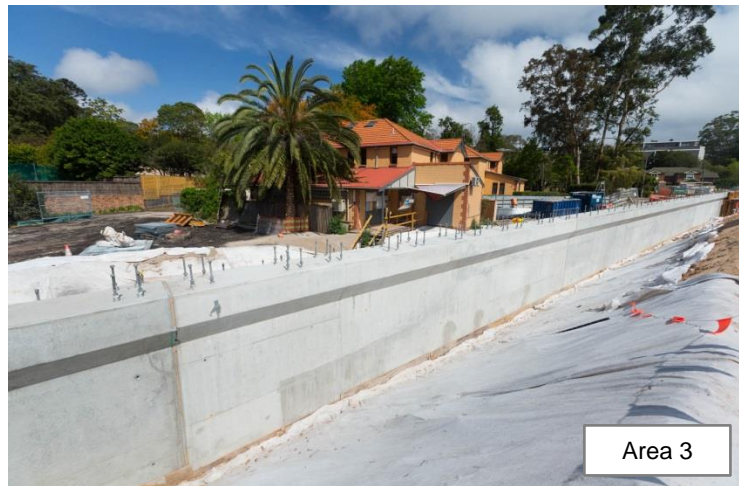
Photo 81 and 82: Batters from the piling pad covered in geo-fabric

Following the installation of the temporary creek realignment channel behind retaining wall 2, the commencement of the piling pad construction occurred to form the final retaining wall for the entrance to the tunnel. This entailed backfilling an area of approximately 0.91ha to the level of the retaining wall to enable piling and associated piling activities to occur. A high degree of care was taken as the works remained in close proximity to the creek, with all batters covered and secured with geo-fabric or sprayed with Vital Chemicals soil binder. Various oil binder types were utilised depending on the area such as spraying heavy duty haul roads or batters.

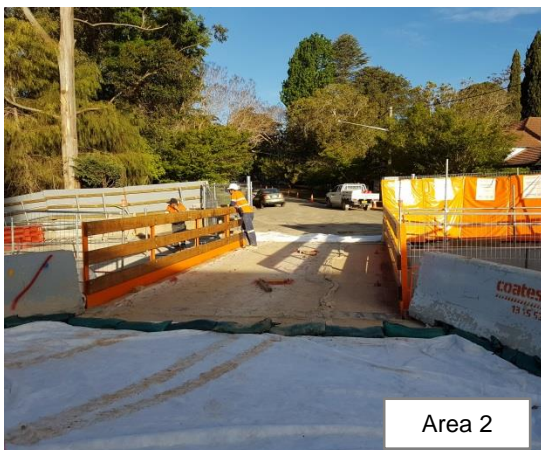
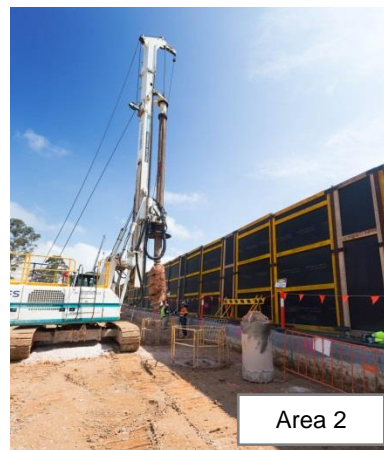
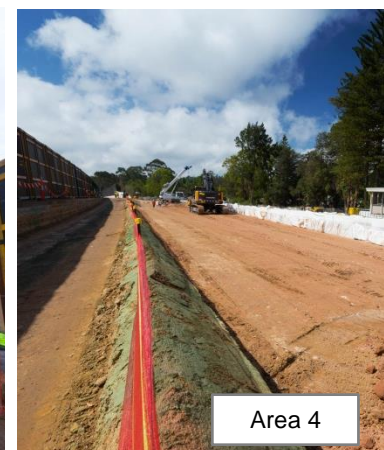
Photo 83: Bailey Bridge with environmental controls installed at Burns Road. Photo 84: Piling the remaining retaining wall adjacent to the M1 Pacific Motorway. Photo 85: Batters along the piling pad sprayed with Vital Chemicals soil binder

As the temporary crossing at 2B Burns Road were removed, access was created to the work area along Burns Road by a Bailey Bridge installed across the two retaining walls to facilitate the delivery of material for the piling pad and access for all piling associated activities.

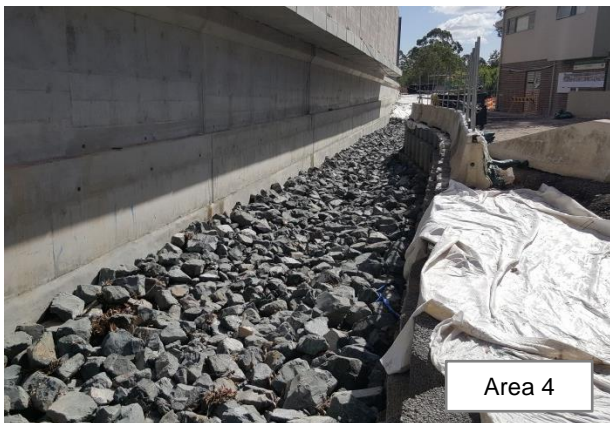
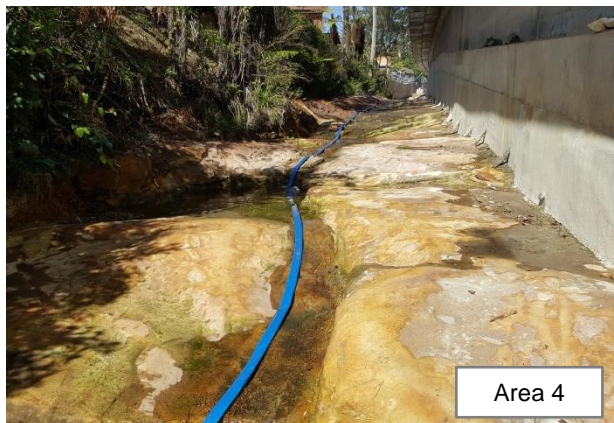
Photo 86 and 87: Sections of Cockle Creek realigned into the permanent channel, with both natural bedrock and basalt rock

The rehabilitation of Cockle Creek involved a number of areas to be treated with rip rap ranging in size from 300mm to 750mm diameter, due to the variation on the existing creek bed conditions. There are four rock pools along the length of the creek alignment, which were treated on a location by location basis depending on the creek bed conditions. The eastern side of the realigned creek was rehabilitated with a diverse range of native vegetation in accordance with DPI water guidelines.

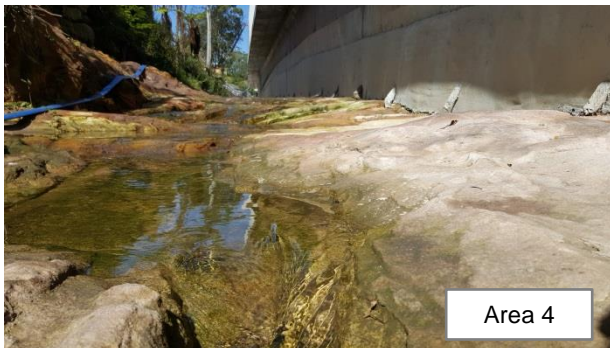
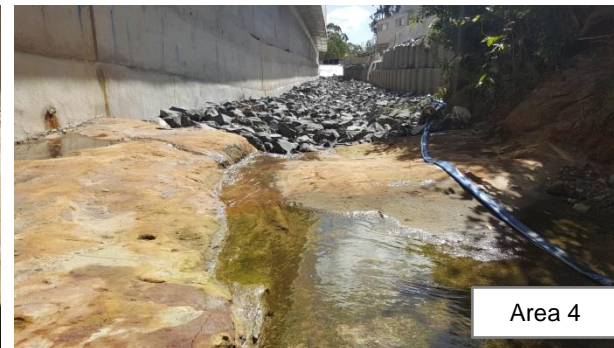
Photo 88 and 89: Sections of Cockle Creek realigned into the permanent channel, with both natural bedrock and basalt rock

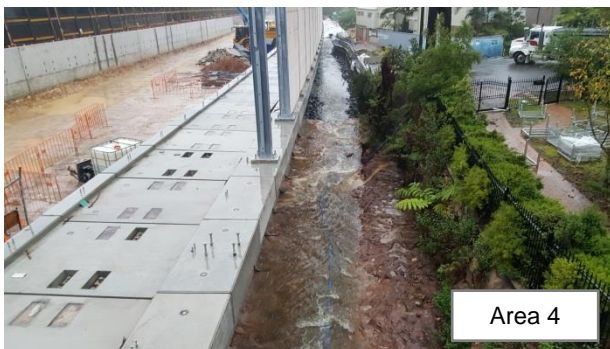
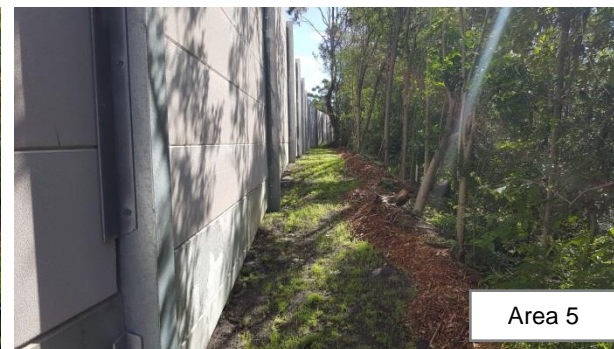
Photo 90: The realigned channel flowing during a rain event. Photo 91: Seed planted behind the newly installed noise wall adjacent to Cockle Creek

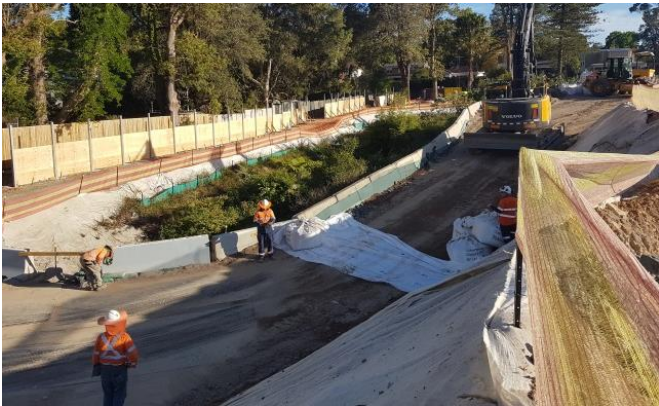
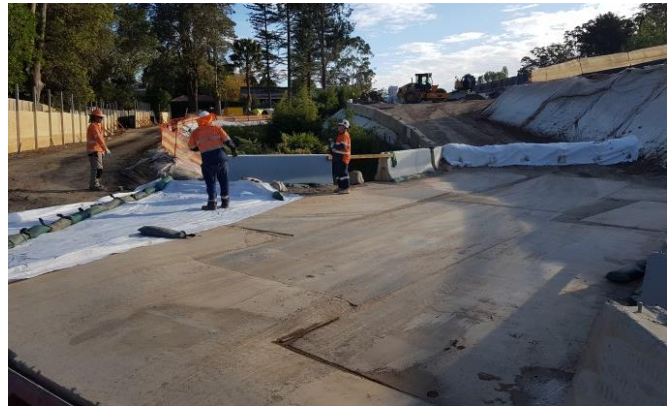
Photo 92 and 93: Progressively installing bulka bags wrapped and secured with geo-fabric at Lochville Street temporary crossing, prior to a rain event

- » Ensure steel plates on the temporary crossings are cleaned daily;
- » Sandbags and geo-fabric to be placed on either side of the access track at the temporary crossings, at the end of each day;
- » Barriers across the temporary crossing to be moved, to allow the natural flow of the creek to overtop in the event of high rainfall;
- » Bulka bag barrier is installed at Lochville Crossing, to act as a sump, to capture any runoff from the steep access track and protect Cockle Creek; and
- » Ensure the temporary crossing pipes are free from debris or rubbish.

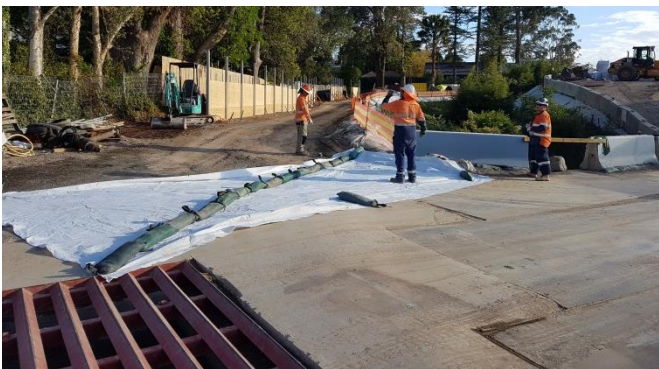
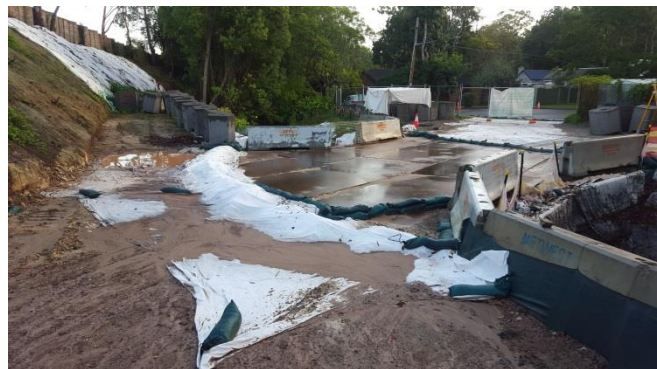
Photo 94: Sandbag bund directing any dirty water runoff from the access track to the rumble grid, which was specifically designed to have the capacity of a small sump due to the access location being next to the creek. Photo 95: Post rain showing the sediment captured with the bunding, preventing any dirty water runoff into Cockle Creek

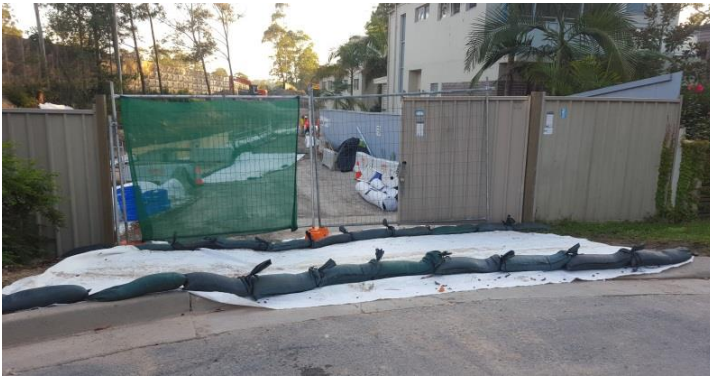
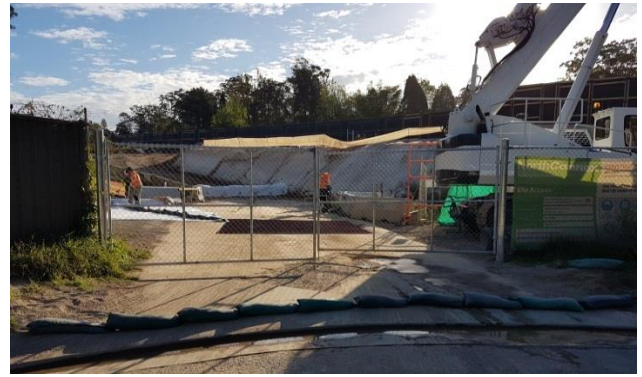
Photo 96 & 97: Shutdown controls at the access points to site.

- » Sandbag bunding and geo-fabric is positioned at the access points from Burns Road, Bareena Avenue and Lochville Street.

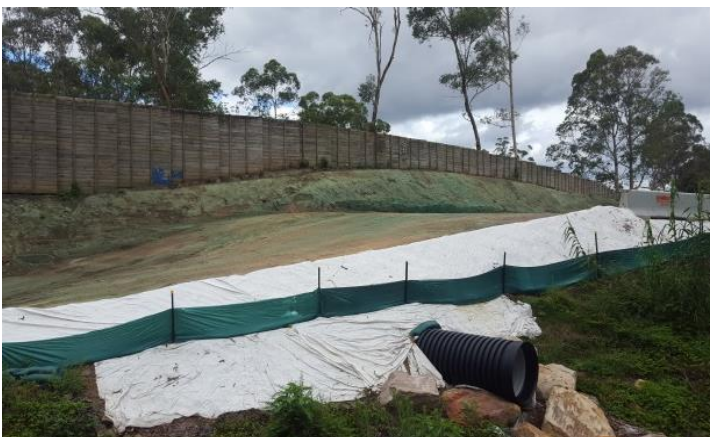
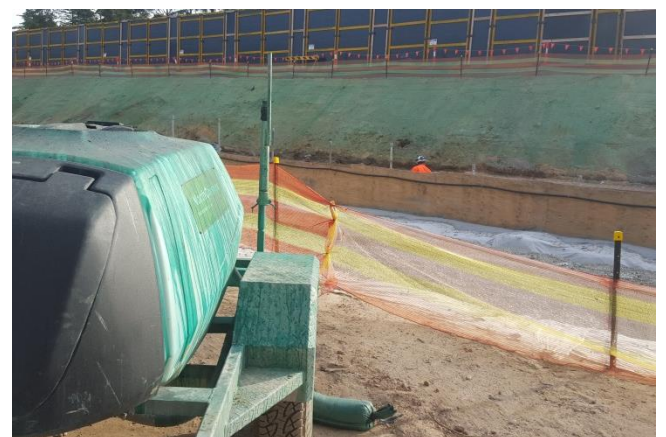
Photo 98: Area stabilised with soil binder and batters secured with geo-fabric along Cockle Creek. Photo 99: Soil binder unit utilising Vital Chemical soil binder products, and sprayed batter in the background

- » Batters are stabilised and secured with geo-fabric, or sprayed with soil binder;
- » Any piling pads to be sprayed with soil binder;
- » Stockpiles sprayed with soil binder or secured with geo-fabric; and
- » Sandbag breaks installed along access tracks.

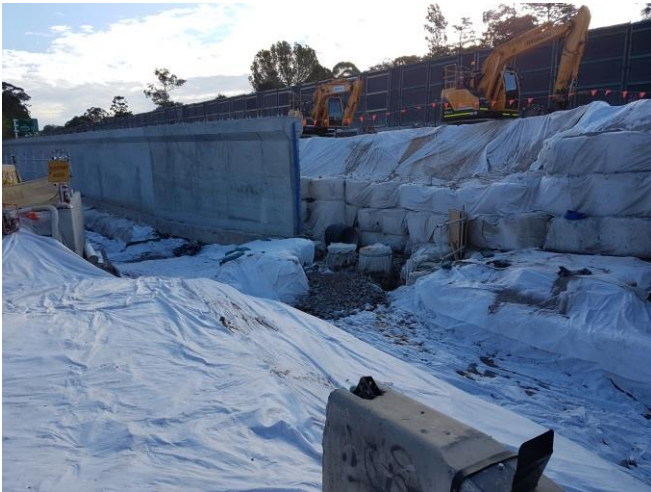
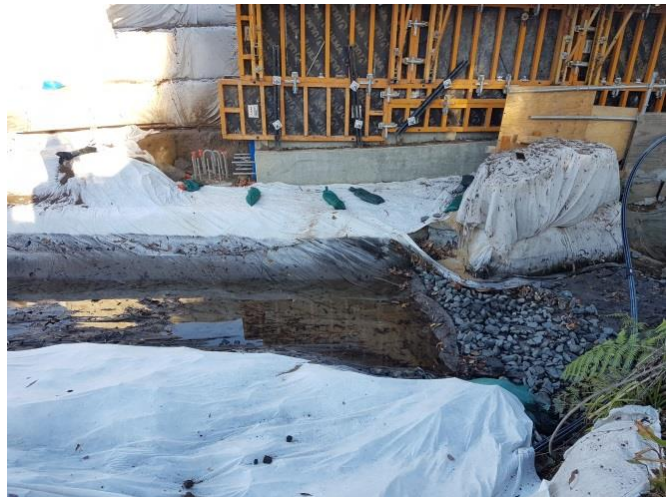
Photo 100 and 101: Area at 2B Burns Road stabilised and secured with geo-fabric, and the excavated channel lined with geo-fabric

- » Remove materials and plant from the permanent alignment channel, and line and secure with geo-fabric (refer to photos 100 to 102 below); and
- » Ensure all areas around the creek are stabilised and secured with geo-fabric.

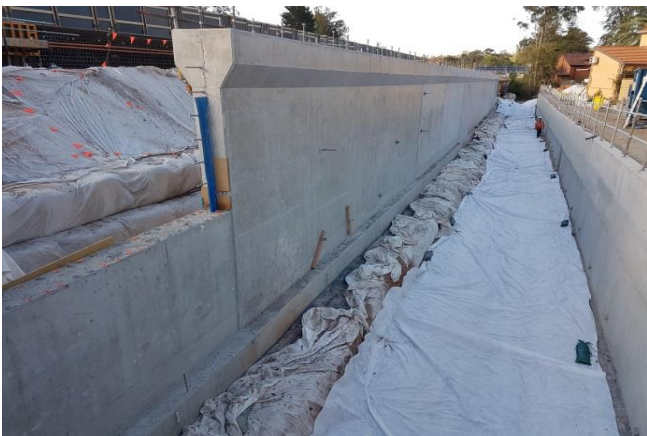
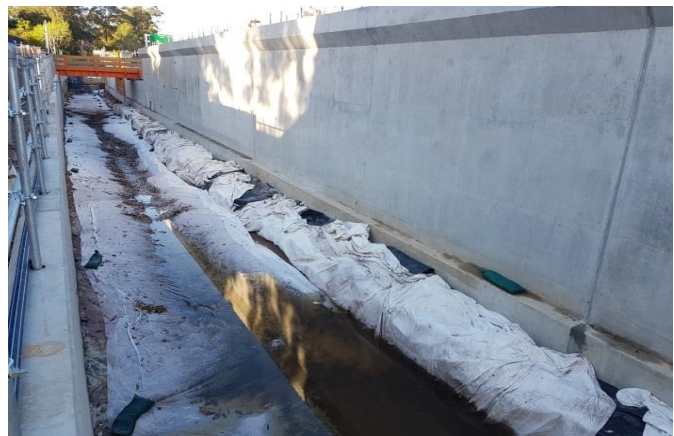
Photo 102: Permanent alignment channel secured with geo-fabric prior to a rain event. Photo 103: Permanent alignment channel following a rain event

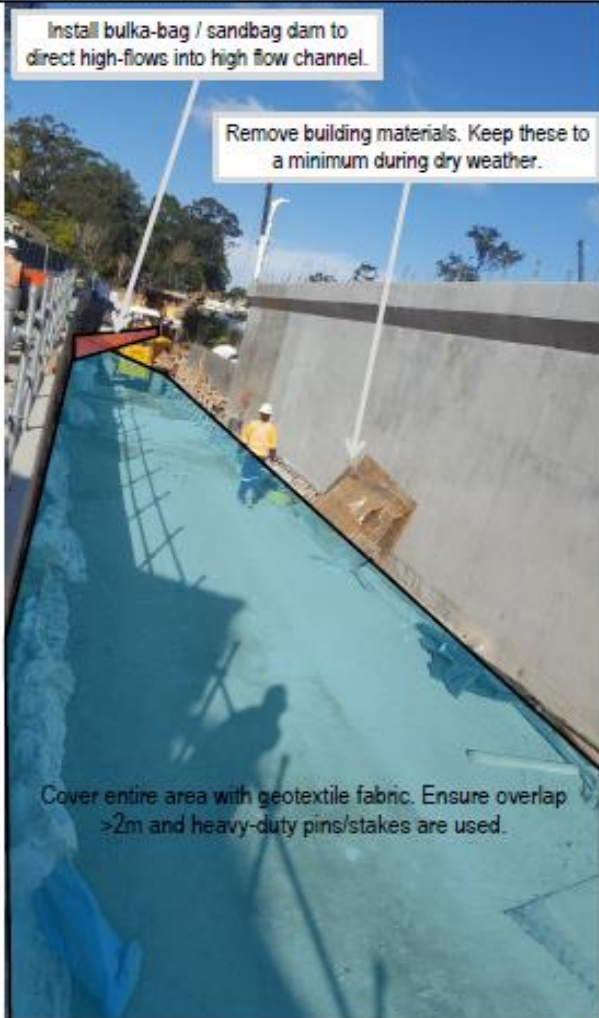
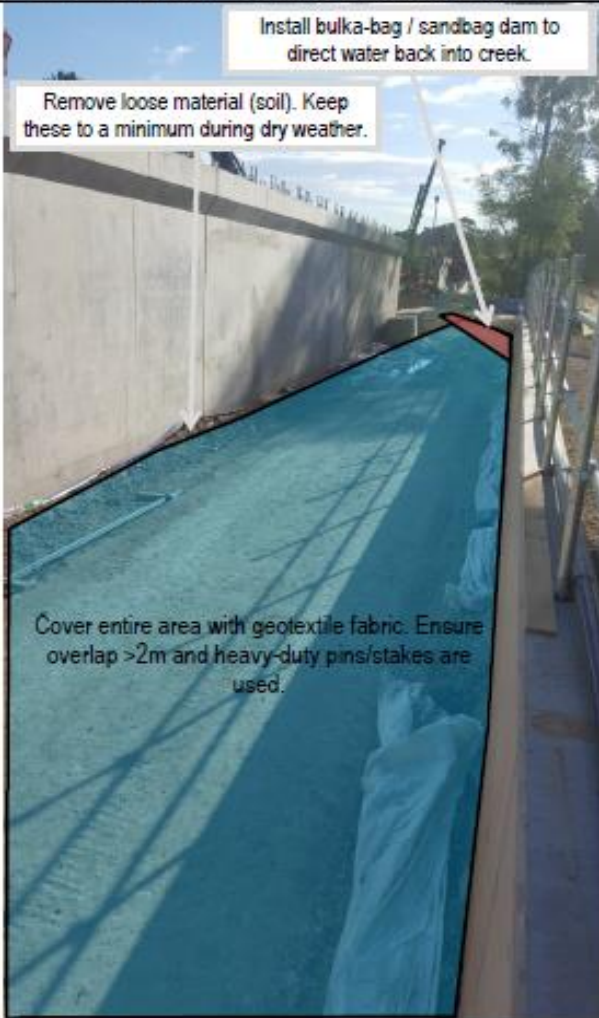
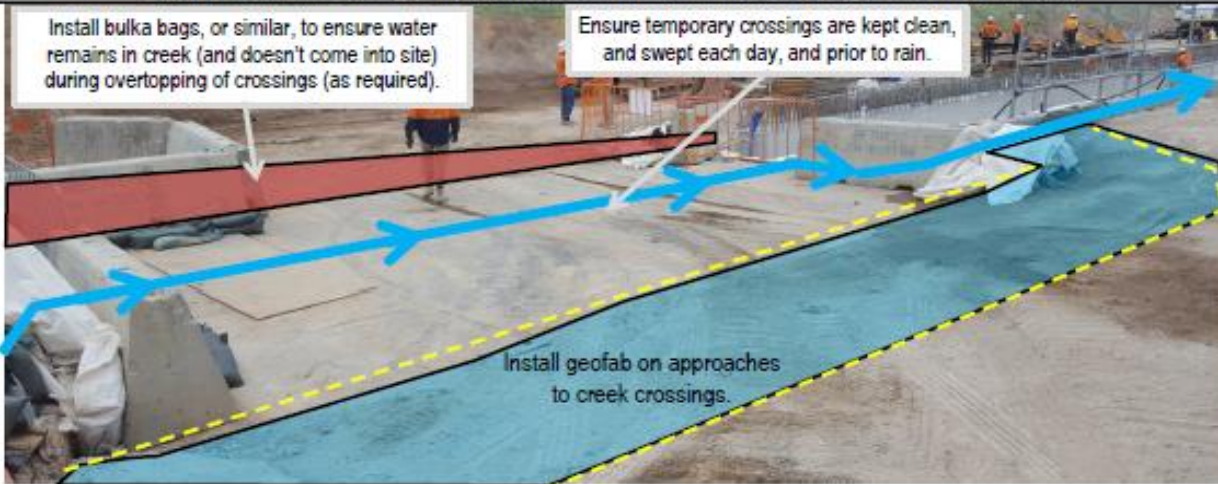
Figure 22: Cockle Creek rain preparation checklist

Controls to be installed prior to rain (Forecast > 12-15mm)	
High-flow path - Looking south/upstream	High-flow path - Looking north/downstream
<p>Install bulka-bag / sandbag dam to direct high-flows into high flow channel.</p> <p>Remove building materials. Keep these to a minimum during dry weather.</p>

<p>Cover entire area with geotextile fabric. Ensure overlap >2m and heavy-duty pins/stakes are used.</p>	<p>Install bulka-bag / sandbag dam to direct water back into creek.</p> <p>Remove loose material (soil). Keep these to a minimum during dry weather.</p>

<p>Cover entire area with geotextile fabric. Ensure overlap >2m and heavy-duty pins/stakes are used.</p>
Typical Creek Crossing preparation >15mm rain forecast (e.g. Barena Avenue)	
<p>Install bulka bags, or similar, to ensure water remains in creek (and doesn't come into site) during overtopping of crossings (as required).</p> <p>Ensure temporary crossings are kept clean, and swept each day, and prior to rain.</p>

<p>Install geofab on approaches to creek crossings.</p>
